SINGLE SURVEY  
ENERGY REPORT  
PROPERTY QUESTIONNAIRE  
VALUATION REPORT

# Single Survey

<b>Property address</b>	Lonsdale, Albert Street, Forres, IV36 1PP
-------------------------	--

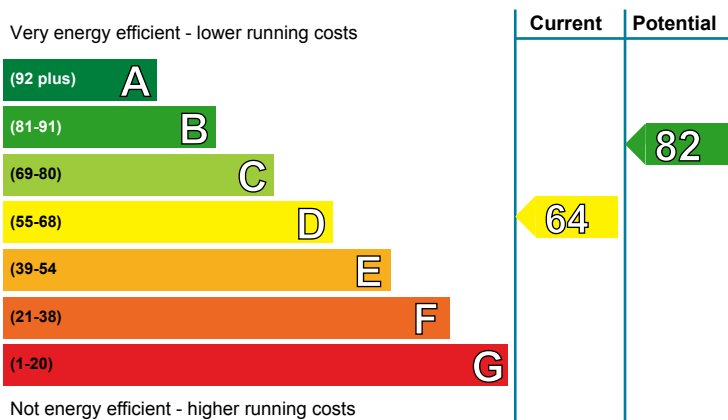
## Energy Efficiency Rating

This graph shows the current efficiency of your home, taking into account both energy efficiency and fuel costs. The higher this rating, the lower your fuel bills are likely to be.

Your current rating is **band D (64)**. The average rating for EPCs in Scotland is **band D (61)**.

The potential rating shows the effect of undertaking all of the improvement measures listed within your recommendations report.

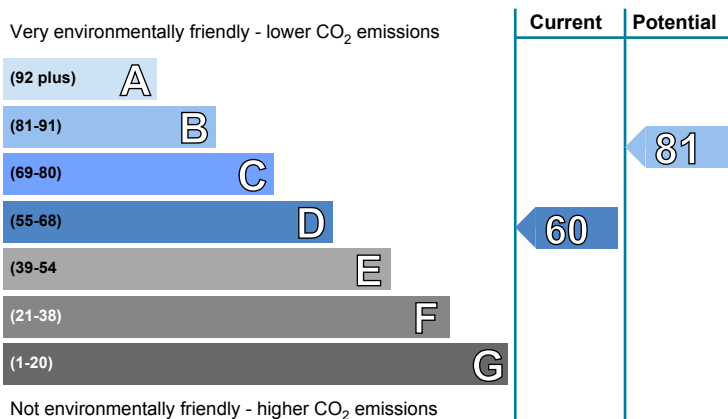
## Environmental Impact (CO<sub>2</sub>) Rating

This graph shows the effect of your home on the environment in terms of carbon dioxide (CO<sub>2</sub>) emissions. The higher the rating, the less impact it has on the environment.
