home report

**34 ANDERSON CRESCENT
FORRES
IV36 1ND**

Energy Performance Certificate (EPC)

34 ANDERSON CRESCENT, FORRES, IV36 1ND

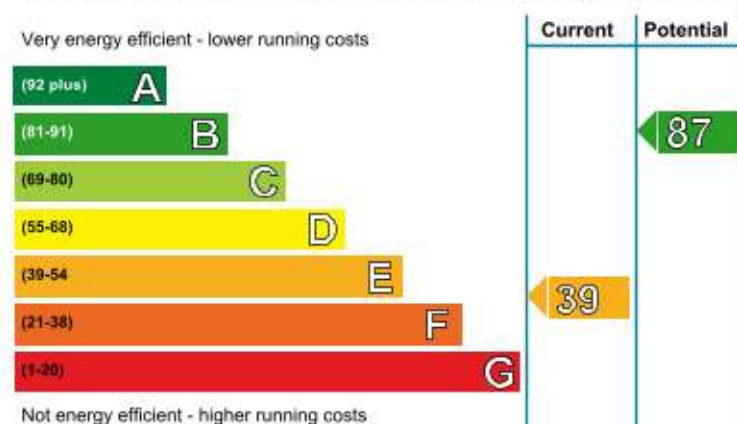
Energy Efficiency Rating

This graph shows the current efficiency of your home, taking into account both energy efficiency and fuel costs. The higher this rating, the lower your fuel bills are likely to be.

Your current rating is **band E (39)**. The average rating for EPCs in Scotland is **band D (61)**.

The potential rating shows the effect of undertaking all of the improvement measures listed within your recommendations report.

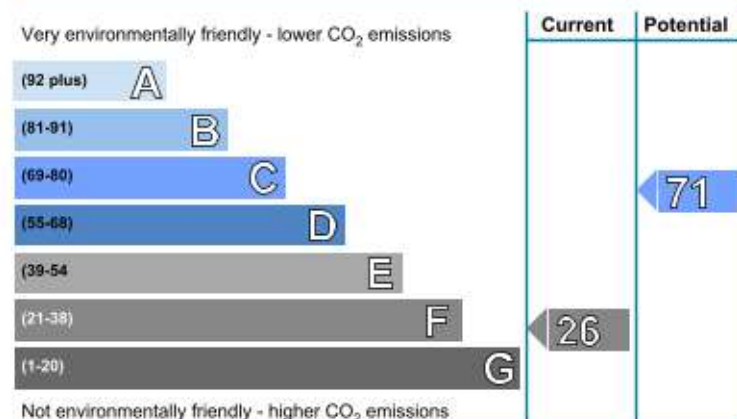
Environmental Impact (CO₂) Rating

This graph shows the effect of your home on the environment in terms of carbon dioxide (CO₂) emissions. The higher the rating, the less impact it has on the environment.

Your current rating is **band F (26)**. The average rating for EPCs in Scotland is **band D (59)**.

The potential rating shows the effect of undertaking all of the improvement measures listed within your recommendations report.
