HOME
report

SINGLE SURVEY
ENERGY REPORT
PROPERTY QUESTIONNAIRE
VALUATION REPORT

Single Survey

Property address	Old Smithy, Auchindoun, Keith, AB55 4DY
-------------------------	--

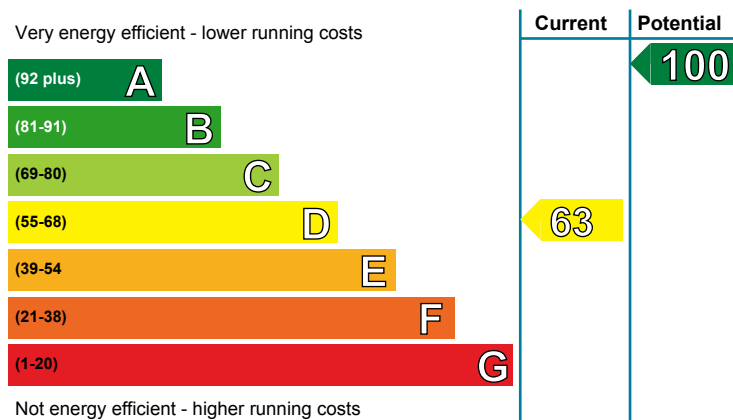
Energy Efficiency Rating

This graph shows the current efficiency of your home, taking into account both energy efficiency and fuel costs. The higher this rating, the lower your fuel bills are likely to be.

Your current rating is **band D (63)**. The average rating for EPCs in Scotland is **band D (61)**.

The potential rating shows the effect of undertaking all of the improvement measures listed within your recommendations report.

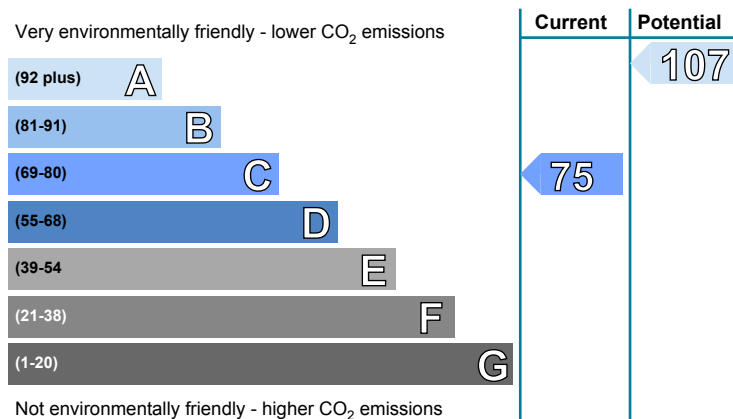
Environmental Impact (CO₂) Rating

This graph shows the effect of your home on the environment in terms of carbon dioxide (CO₂) emissions. The higher the rating, the less impact it has on the environment.
