### survey report on:

Property address	Balgownie Croft, Forres, IV36 2RW
Customer	Mr W Finlayson
Customer address	
Prepared by	Harvey Donaldson And Gibson
Date of inspection	25th March 2022

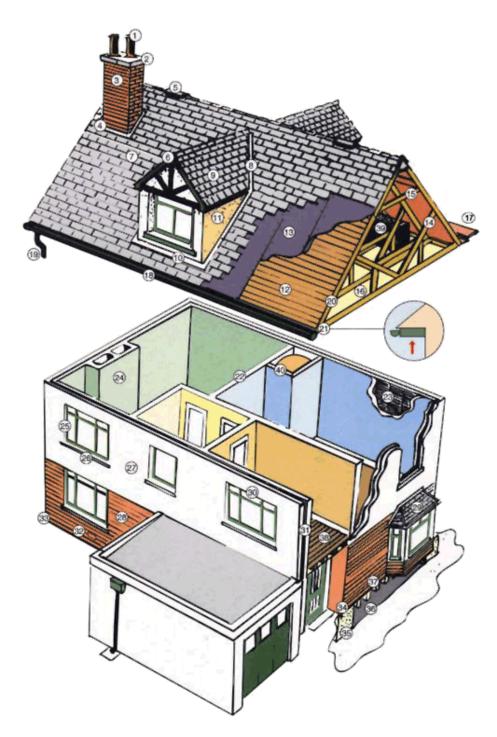
#### Sectional Diagram showing elements of a typical house

Reference may be made in this report to some or all of the above component parts of the property. This diagram may assist you in locating and understanding these items.

- 1) Chimney pots
- 2) Coping stone
- 3) Chimney head
- 4 Flashing
- 5 Ridge ventilation
- 6) Ridge board
- 7) Slates / tiles
- 8 Valley guttering
- 9 Dormer projection
- 10 Dormer flashing
- 11) Dormer cheeks
- (12) Sarking
- 13) Roof felt
- (14) Trusses
- (15) Collar
- (16) Insulation
- (17) Parapet gutter
- (18) Eaves guttering
- Rainwater downpipe
- 20) Verge boards/skews
- 21) Soffit boards
- 22) Partition wall
- 23) Lath / plaster
- 24) Chimney breast
- 25) Window pointing
- 6) Window sills
- 27) Rendering
- (28) Brickwork / pointing
- 29) Bay window projection
- 30 Lintels
- (31) Cavity walls / wall ties
- 32) Subfloor ventilator
- 33) Damp proof course
- 34) Base course
- Foundations
- 36) Solum
- 37) Floor joists
- 38) Floorboards
- 39) Water tank
- 40 Hot water tank
