HOME
report

SINGLE SURVEY
ENERGY REPORT
PROPERTY QUESTIONNAIRE
VALUATION REPORT

Single Survey

Property address	27 Brodie Drive, Elgin, IV30 4LS
-------------------------	--

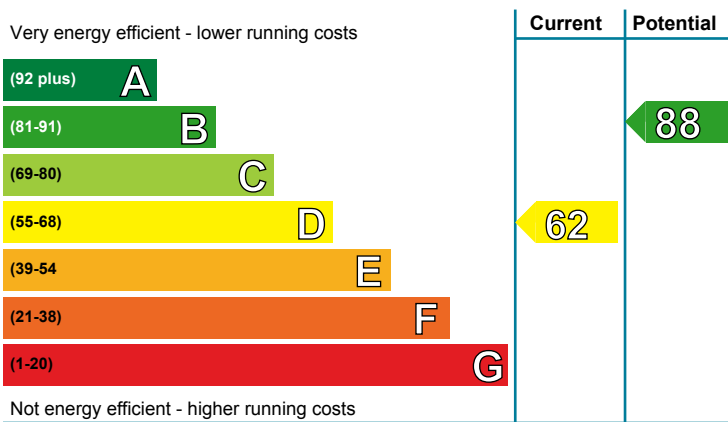
Energy Efficiency Rating

This graph shows the current efficiency of your home, taking into account both energy efficiency and fuel costs. The higher this rating, the lower your fuel bills are likely to be.

Your current rating is **band D (62)**. The average rating for EPCs in Scotland is **band D (61)**.

The potential rating shows the effect of undertaking all of the improvement measures listed within your recommendations report.

Estimated energy costs for your home for 3 years*	£2,358	See your recommendations report for more information
Over 3 years you could save*	£867

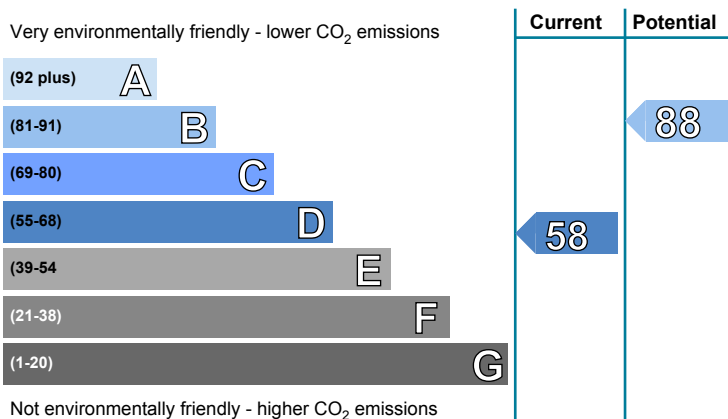
Environmental Impact (CO₂) Rating

This graph shows the effect of your home on the environment in terms of carbon dioxide (CO₂) emissions. The higher the rating, the less impact it has on the environment.
