HOME
report

SINGLE SURVEY
ENERGY REPORT
PROPERTY QUESTIONNAIRE
VALUATION REPORT

Single Survey

Property address	Broomknowe, Findhorn, Forres, IV36 3RY
-------------------------	---

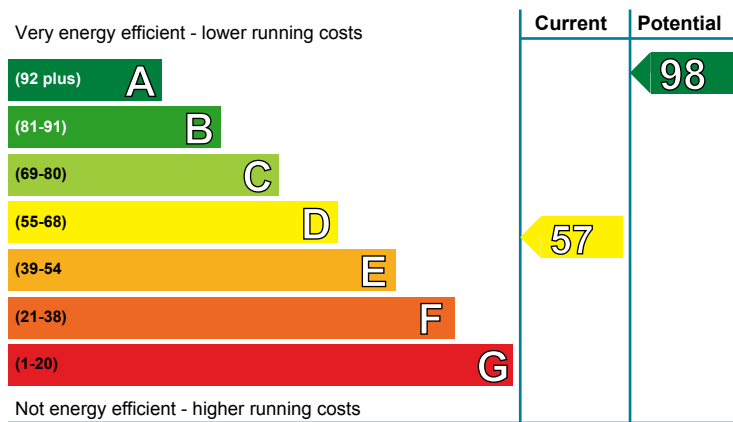
Energy Efficiency Rating

This graph shows the current efficiency of your home, taking into account both energy efficiency and fuel costs. The higher this rating, the lower your fuel bills are likely to be.

Your current rating is **band D (57)**. The average rating for EPCs in Scotland is **band D (61)**.

The potential rating shows the effect of undertaking all of the improvement measures listed within your recommendations report.

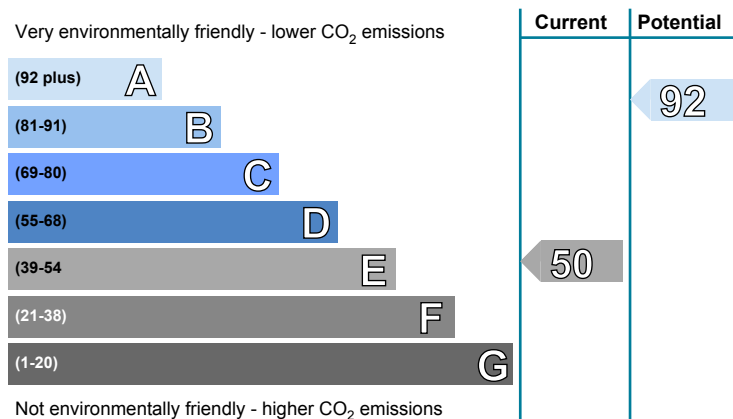
Environmental Impact (CO₂) Rating

This graph shows the effect of your home on the environment in terms of carbon dioxide (CO₂) emissions. The higher the rating, the less impact it has on the environment.
