HOME REPORT

Lagual
Chapletown
Ballindalloch
AB37 9JS

Energy Performance Certificate (EPC)

Lagual, Chapletown, Ballindalloch, AB37 9JS

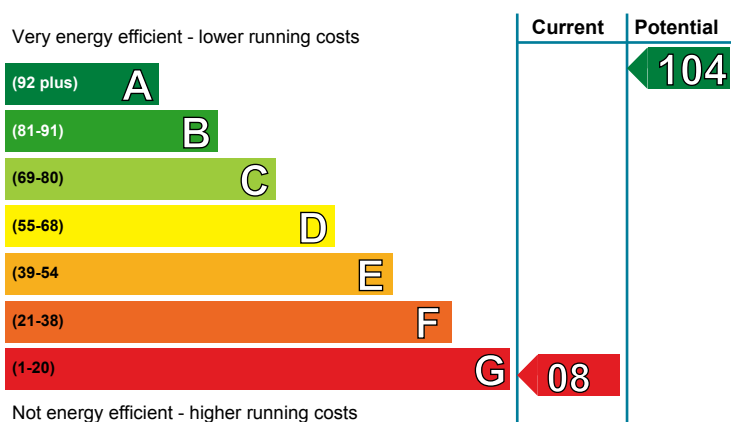
Energy Efficiency Rating

This graph shows the current efficiency of your home, taking into account both energy efficiency and fuel costs. The higher this rating, the lower your fuel bills are likely to be.

Your current rating is **band G (8)**. The average rating for EPCs in Scotland is **band D (61)**.

The potential rating shows the effect of undertaking all of the improvement measures listed within your recommendations report.

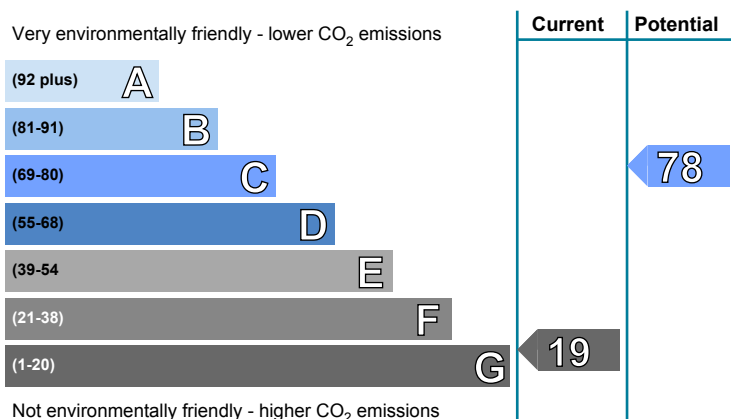
Environmental Impact (CO₂) Rating

This graph shows the effect of your home on the environment in terms of carbon dioxide (CO₂) emissions. The higher the rating, the less impact it has on the environment.

Your current rating is **band G (19)**. The average rating for EPCs in Scotland is **band D (59)**.

The potential rating shows the effect of undertaking all of the improvement measures listed within your recommendations report.
