HOME
report

SINGLE SURVEY
ENERGY REPORT
PROPERTY QUESTIONNAIRE
VALUATION REPORT

Single Survey

Property Address	Flat 4 9 Commerce Street Elgin IV30 1BS
Customer	Ms R Pepper
Date of Inspection	30/05/2025
Prepared by	Donna Shields Harvey Donaldson & Gibson Chartered Surveyors

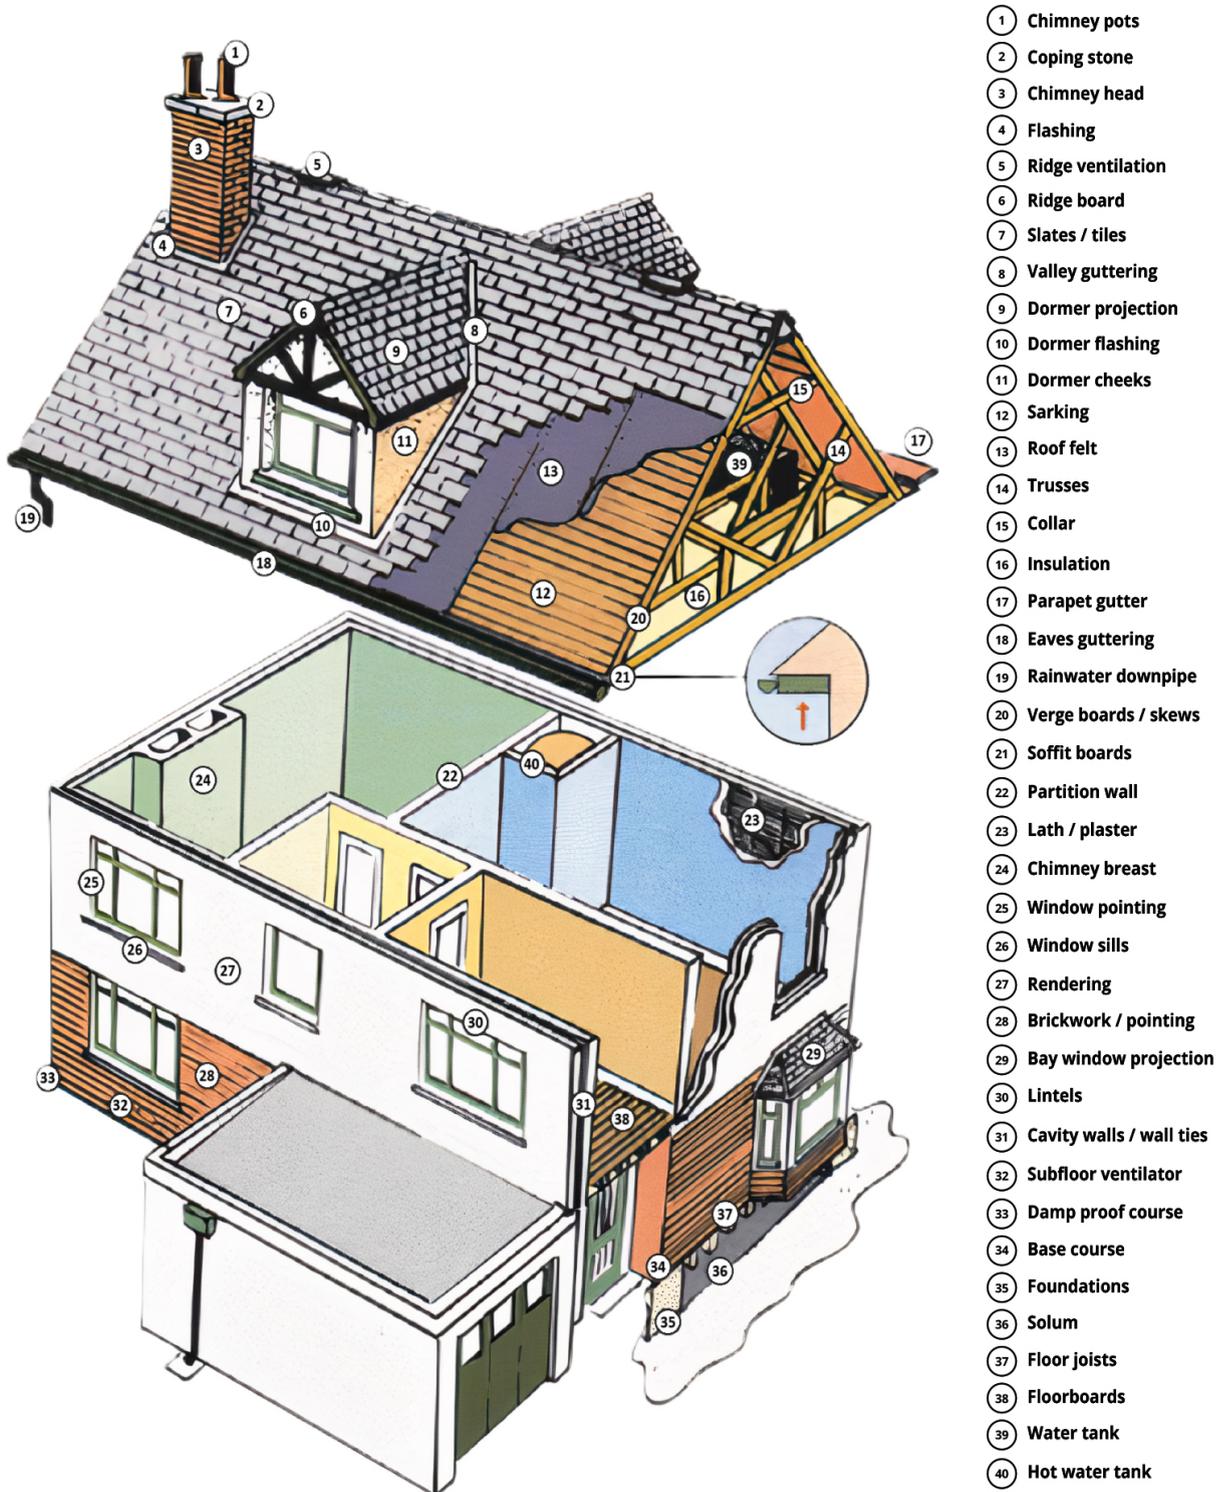
Sectional Diagram showing elements of a typical house

Reference may be made in this report to some or all of the above component parts of the property. This diagram may assist you in locating and understanding these items.

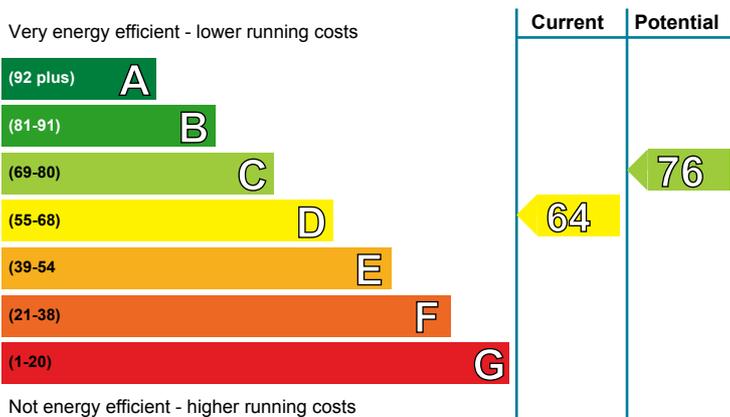
Energy Efficiency Rating

This graph shows the current efficiency of your home, taking into account both energy efficiency and fuel costs. The higher this rating, the lower your fuel bills are likely to be.

Your current rating is **band D (64)**. The average rating for EPCs in Scotland is **band D (61)**.

The potential rating shows the effect of undertaking all of the improvement measures listed within your recommendations report.

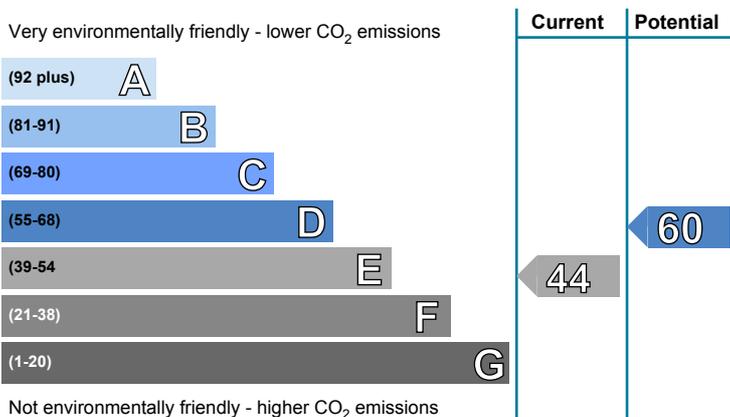
Environmental Impact (CO₂) Rating

This graph shows the effect of your home on the environment in terms of carbon dioxide (CO₂) emissions. The higher the rating, the less impact it has on the environment.
