SINGLE SURVEY
ENERGY REPORT
PROPERTY QUESTIONNAIRE
VALUATION REPORT

Single Survey

Property address	Flat 9 Culbin Sands Apartments, Findhorn, Forres, IV36 3QJ
-------------------------	---

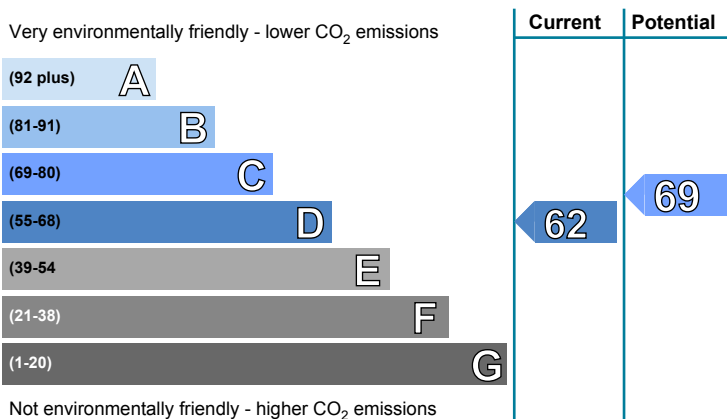
Environmental Impact (CO₂) Rating

This graph shows the effect of your home on the environment in terms of carbon dioxide (CO₂) emissions. The higher the rating, the less impact it has on the environment.
