Energy performance certificate (EPC)

5 Dan Y Coed Cefn Hengoed HENGOED CF82 7LP	Energy rating <div>C</div>	Valid until: 20 February 2033
		Certificate number: 8907-2222-7340-0050-0226

Property type
Detached bungalow

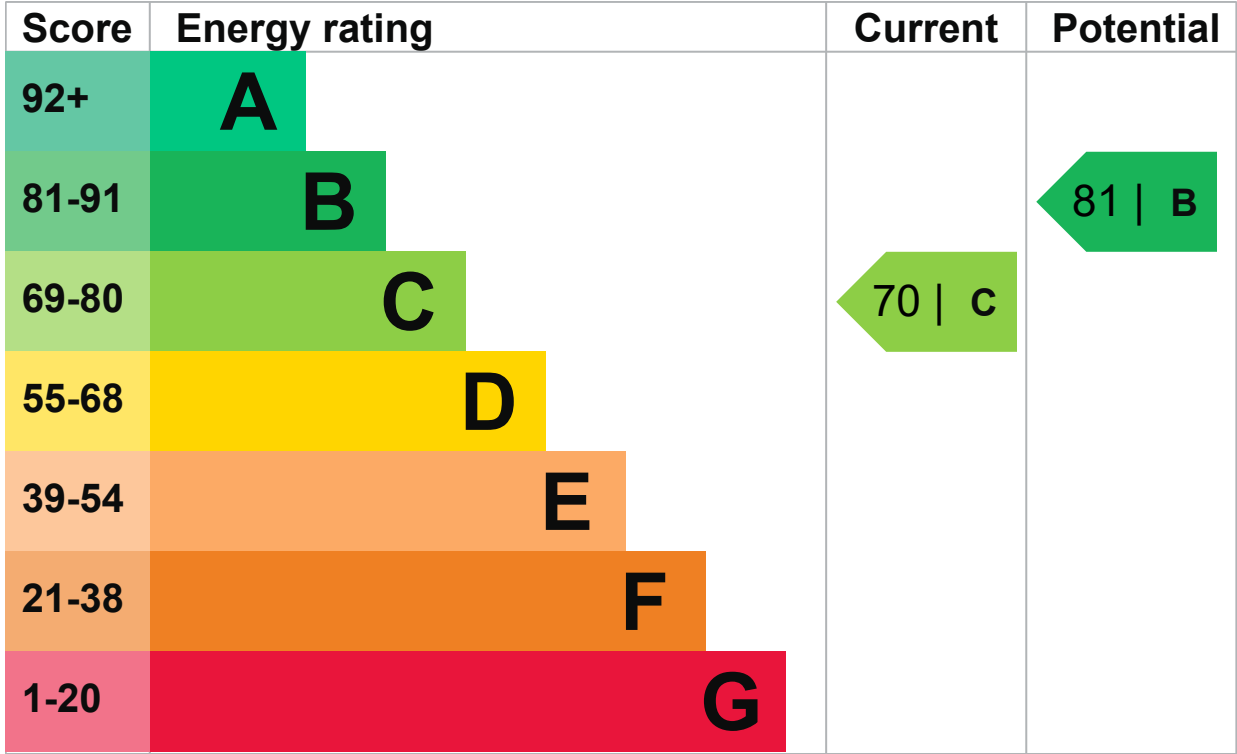
This property’s current energy rating is C. It has the potential to be B.

The graph shows this property’s current and potential energy rating.
