- 1. Single Survey
- 2. Energy Report
- 3. Property Questionnaire

### survey report on:

Property address       162 Douglas Crescent,         Buckie,       AB56 1NF
---

Prepared by Harvey Donaldson And Gibson	Prepared by	Harvey Donaldson And Gibson
---	-------------	-----------------------------

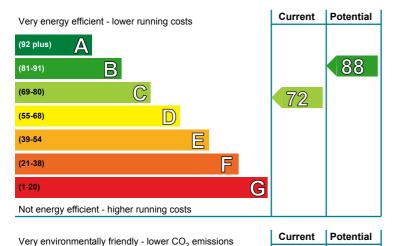
#### **Energy Efficiency Rating**

This graph shows the current efficiency of your home, taking into account both energy efficiency and fuel costs. The higher this rating, the lower your fuel bills are likely to be.
