14 DUFF STREET
HOPEMAN
ELGIN
IV30 5RZ

Home Report

14 DUFF STREET, HOPEMAN, ELGIN, IV30 5RZ

Scottish Single Survey

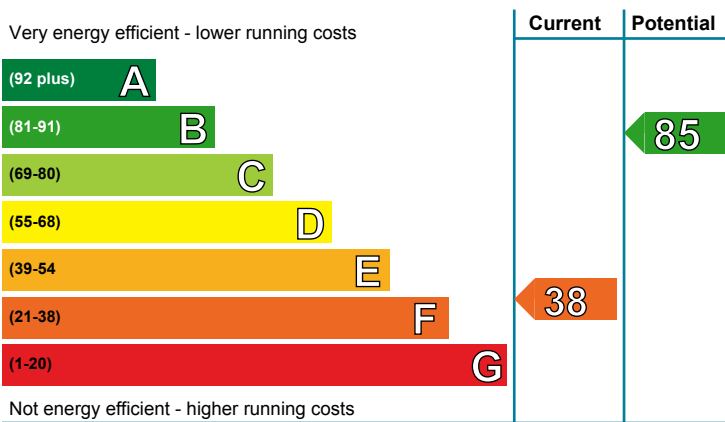
Energy Efficiency Rating

This graph shows the current efficiency of your home, taking into account both energy efficiency and fuel costs. The higher this rating, the lower your fuel bills are likely to be.

Your current rating is **band F (38)**. The average rating for EPCs in Scotland is **band D (61)**.

The potential rating shows the effect of undertaking all of the improvement measures listed within your recommendations report.

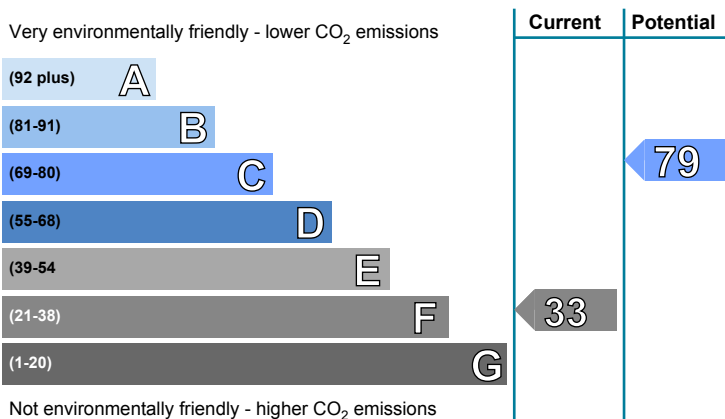
Environmental Impact (CO₂) Rating

This graph shows the effect of your home on the environment in terms of carbon dioxide (CO₂) emissions. The higher the rating, the less impact it has on the environment.

The potential rating shows the effect of undertaking all of the improvement measures listed within your recommendations report.
