HOME
report

SINGLE SURVEY
ENERGY REPORT
PROPERTY QUESTIONNAIRE
VALUATION REPORT

Single Survey

Property address	34 Fleurs Crescent, Forres, IV36 1LZ
-------------------------	--

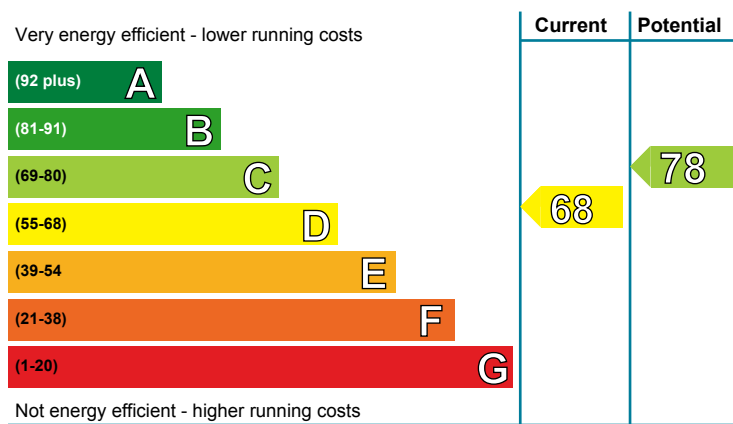
Energy Efficiency Rating

This graph shows the current efficiency of your home, taking into account both energy efficiency and fuel costs. The higher this rating, the lower your fuel bills are likely to be.

Your current rating is **band D (68)**. The average rating for EPCs in Scotland is **band D (61)**.

The potential rating shows the effect of undertaking all of the improvement measures listed within your recommendations report.
