HOME
report

SINGLE SURVEY
ENERGY REPORT
PROPERTY QUESTIONNAIRE
VALUATION REPORT

Single Survey

Property address	69 Forsyth Street, Hopeman, Elgin, IV30 5SY
-------------------------	--

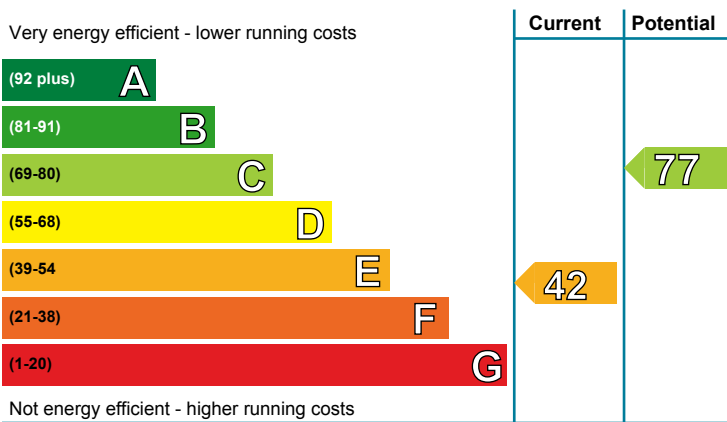
Energy Efficiency Rating

This graph shows the current efficiency of your home, taking into account both energy efficiency and fuel costs. The higher this rating, the lower your fuel bills are likely to be.

Your current rating is **band E (42)**. The average rating for EPCs in Scotland is **band D (61)**.

The potential rating shows the effect of undertaking all of the improvement measures listed within your recommendations report.

Estimated energy costs for your home for 3 years*	£3,606	See your recommendations report for more information
Over 3 years you could save*	£1,449

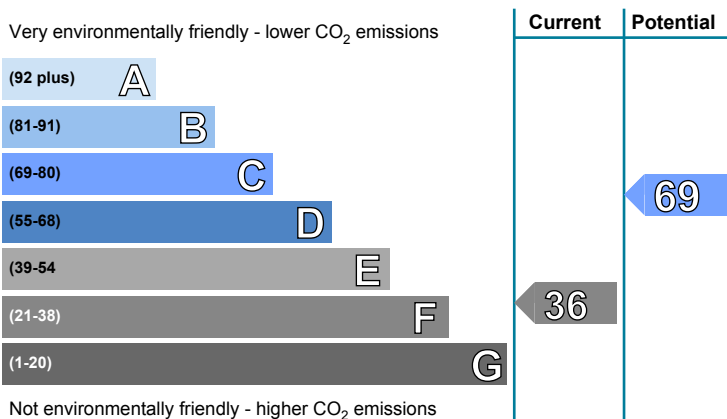
Environmental Impact (CO₂) Rating

This graph shows the effect of your home on the environment in terms of carbon dioxide (CO₂) emissions. The higher the rating, the less impact it has on the environment.
