HOME
report

SINGLE SURVEY
ENERGY REPORT
PROPERTY QUESTIONNAIRE
VALUATION REPORT

Single Survey

Property address	Duncraig, 9 Gordonstoun Road, Duffus, Elgin, IV30 5WE
-------------------------	---

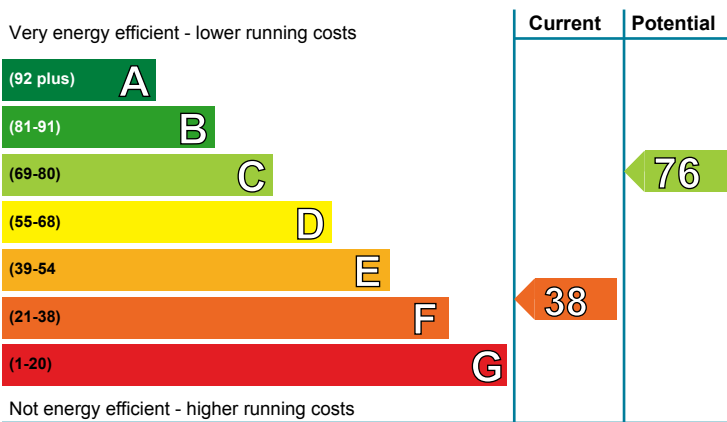
Energy Efficiency Rating

This graph shows the current efficiency of your home, taking into account both energy efficiency and fuel costs. The higher this rating, the lower your fuel bills are likely to be.

Your current rating is **band F (38)**. The average rating for EPCs in Scotland is **band D (61)**.

The potential rating shows the effect of undertaking all of the improvement measures listed within your recommendations report.

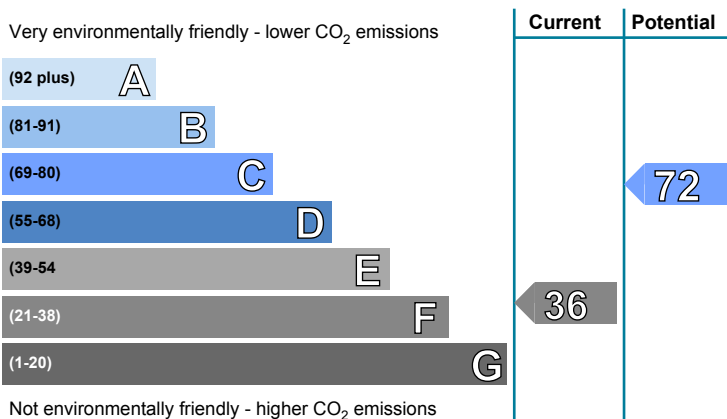
Environmental Impact (CO₂) Rating

This graph shows the effect of your home on the environment in terms of carbon dioxide (CO₂) emissions. The higher the rating, the less impact it has on the environment.
