HOME
report

SINGLE SURVEY
ENERGY REPORT
PROPERTY QUESTIONNAIRE
VALUATION REPORT

Single Survey

Property address	5 Harrow Inn Close, Elgin, IV30 1BP
-------------------------	---

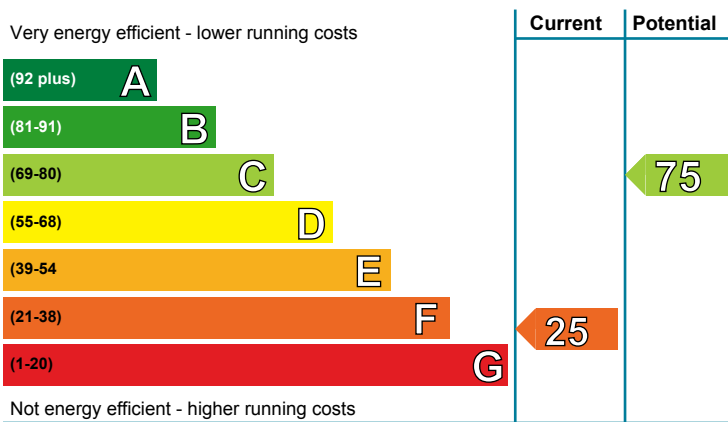
Energy Efficiency Rating

This graph shows the current efficiency of your home, taking into account both energy efficiency and fuel costs. The higher this rating, the lower your fuel bills are likely to be.

Your current rating is **band F (25)**. The average rating for EPCs in Scotland is **band D (61)**.

The potential rating shows the effect of undertaking all of the improvement measures listed within your recommendations report.

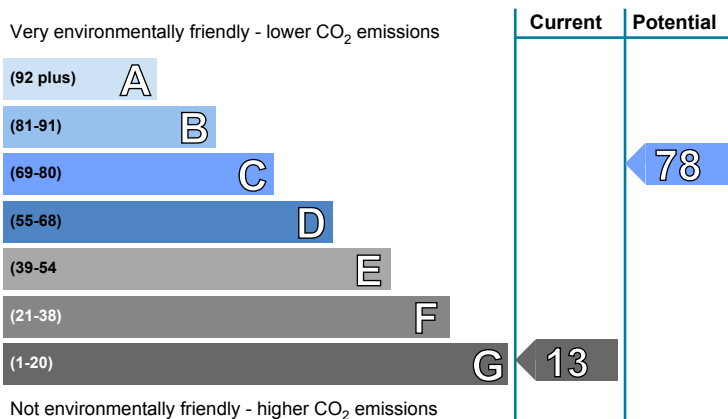
Environmental Impact (CO₂) Rating

This graph shows the effect of your home on the environment in terms of carbon dioxide (CO₂) emissions. The higher the rating, the less impact it has on the environment.
