HOME
report

Single Survey

Property address	46 High Street, Forres, IV36 1PF
-------------------------	--

Date of inspection	24th March 2023
---------------------------	-----------------

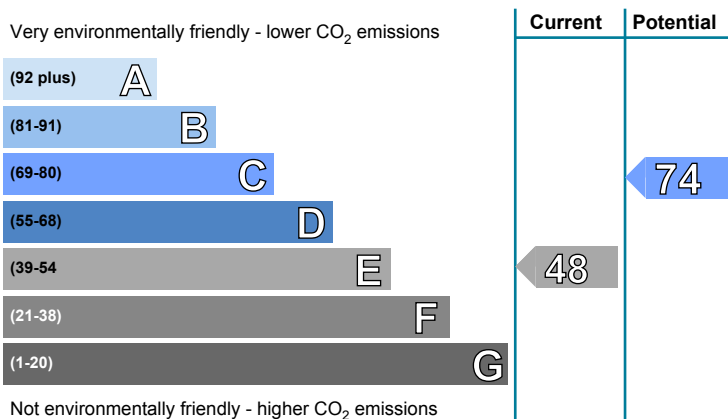
Environmental Impact (CO₂) Rating

This graph shows the effect of your home on the environment in terms of carbon dioxide (CO₂) emissions. The higher the rating, the less impact it has on the environment.
