**HOME**  
report

SINGLE SURVEY  
ENERGY REPORT  
PROPERTY QUESTIONNAIRE  
VALUATION REPORT

| Property Address | 97b High Street Forres IV36 1AA |

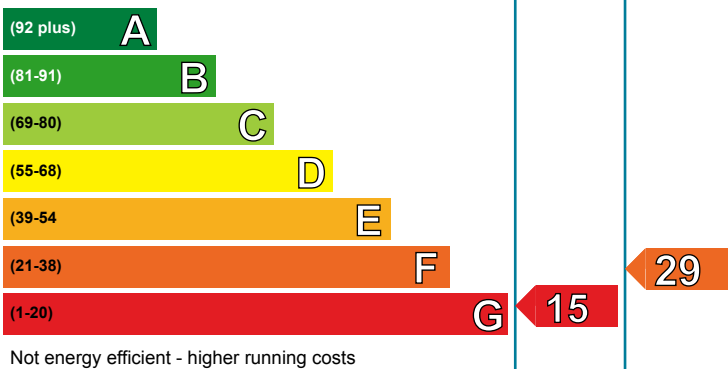
## Energy Efficiency Rating

This graph shows the current efficiency of your home, taking into account both energy efficiency and fuel costs. The higher this rating, the lower your fuel bills are likely to be.

The potential rating shows the effect of undertaking all of the improvement measures listed within your recommendations report.

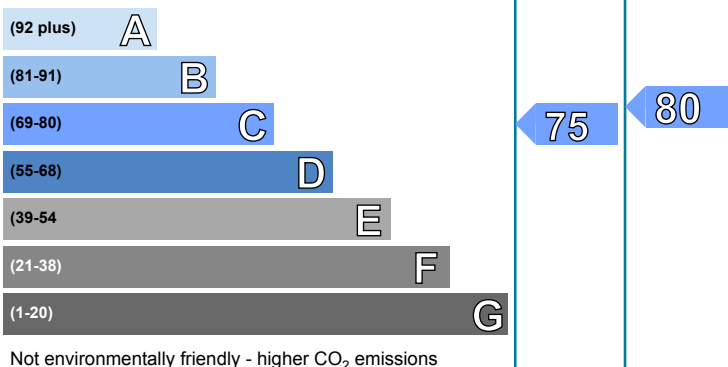
## Environmental Impact (CO<sub>2</sub>) Rating

This graph shows the effect of your home on the environment in terms of carbon dioxide (CO<sub>2</sub>) emissions. The higher the rating, the less impact it has on the environment.
