**HOME**  
report

# Single Survey

<b>Property address</b>	50b High Street, Forres, IV36 1PF
-------------------------	---

<b>Date of inspection</b>	27th January 2022
---------------------------	-------------------

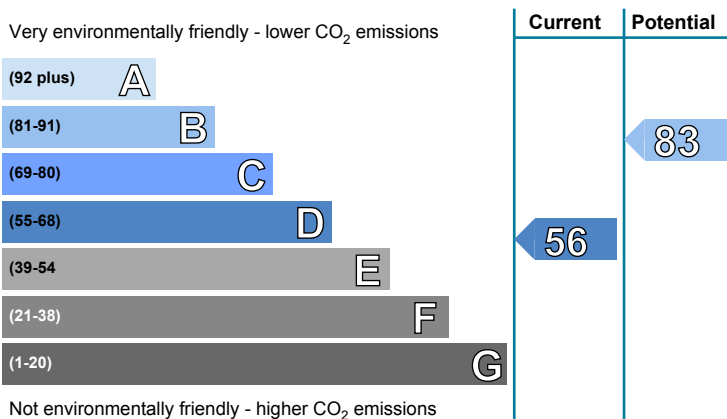
## Environmental Impact (CO<sub>2</sub>) Rating

This graph shows the effect of your home on the environment in terms of carbon dioxide (CO<sub>2</sub>) emissions. The higher the rating, the less impact it has on the environment.
