HOME
report

SINGLE SURVEY
ENERGY REPORT
PROPERTY QUESTIONNAIRE
VALUATION REPORT

Single Survey

Property address	31 Highfield, Forres, IV36 1FN
-------------------------	--------------------------------------

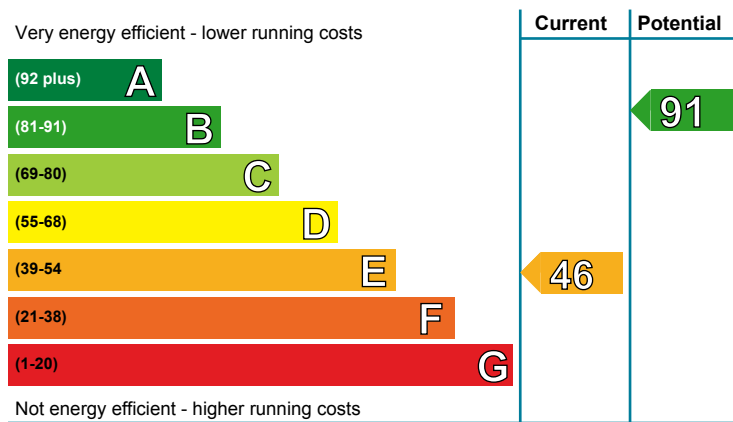
Energy Efficiency Rating

This graph shows the current efficiency of your home, taking into account both energy efficiency and fuel costs. The higher this rating, the lower your fuel bills are likely to be.

Your current rating is **band E (46)**. The average rating for EPCs in Scotland is **band D (61)**.

The potential rating shows the effect of undertaking all of the improvement measures listed within your recommendations report.
