**HOME**  
report

SINGLE SURVEY  
ENERGY REPORT  
PROPERTY QUESTIONNAIRE  
VALUATION REPORT

# Single Survey

<b>Property address</b>	63 King Street, Burghead, Elgin, IV30 5XG
-------------------------	--

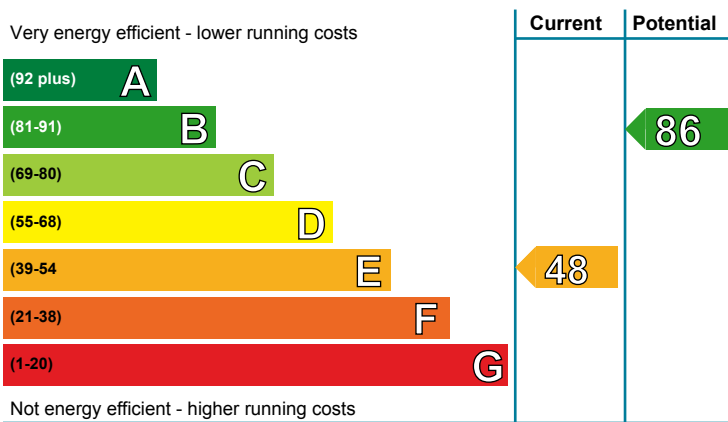
## Energy Efficiency Rating

This graph shows the current efficiency of your home, taking into account both energy efficiency and fuel costs. The higher this rating, the lower your fuel bills are likely to be.

Your current rating is **band E (48)**. The average rating for EPCs in Scotland is **band D (61)**.

The potential rating shows the effect of undertaking all of the improvement measures listed within your recommendations report.
