HOME
report

SINGLE SURVEY
ENERGY REPORT
PROPERTY QUESTIONNAIRE
VALUATION REPORT

Single Survey

Property Address	4 Kirkland Hill Lhanbryde Elgin IV30 8QH
Customer	Ms J Campbell
Date of Inspection	29/06/2026
Prepared by	Kenneth J Silver Harvey Donaldson & Gibson Chartered Surveyors

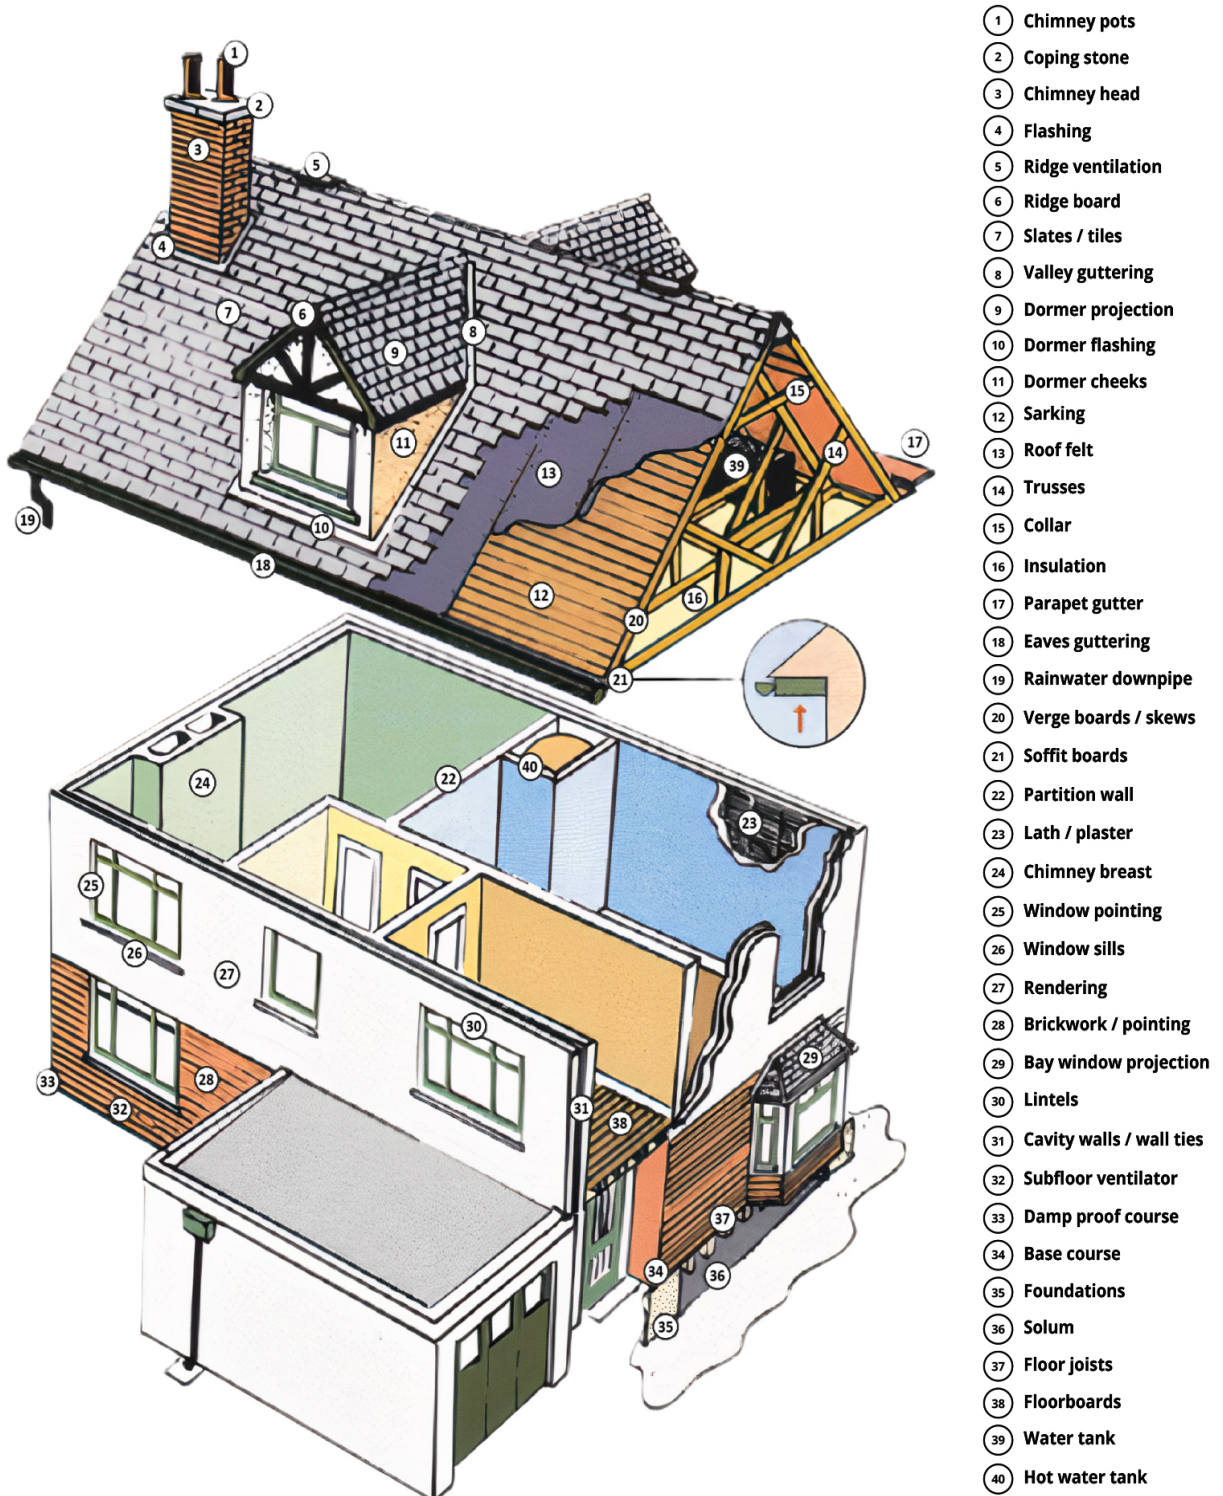
Sectional Diagram showing elements of a typical house

Reference may be made in this report to some or all of the above component parts of the property. This diagram may assist you in locating and understanding these items.
