# YOUR ONESURVEY HOME REPORT

Ruthven Cottage Kirkmichael Ballindalloch AB37 9AR

# SINGLE SURVEY

Customer	Crown Estate Scotland	
Q 111	D. II. O. II	
Selling address	Ruthven Cottage Kirkmichael Ballindalloch AB37 9AR	
Date of Inspection	16/02/2021	
Prepared by	Angus F Gunn BSc MRICS, BSc (Hons) MRICS Allied Surveyors Scotland Plc

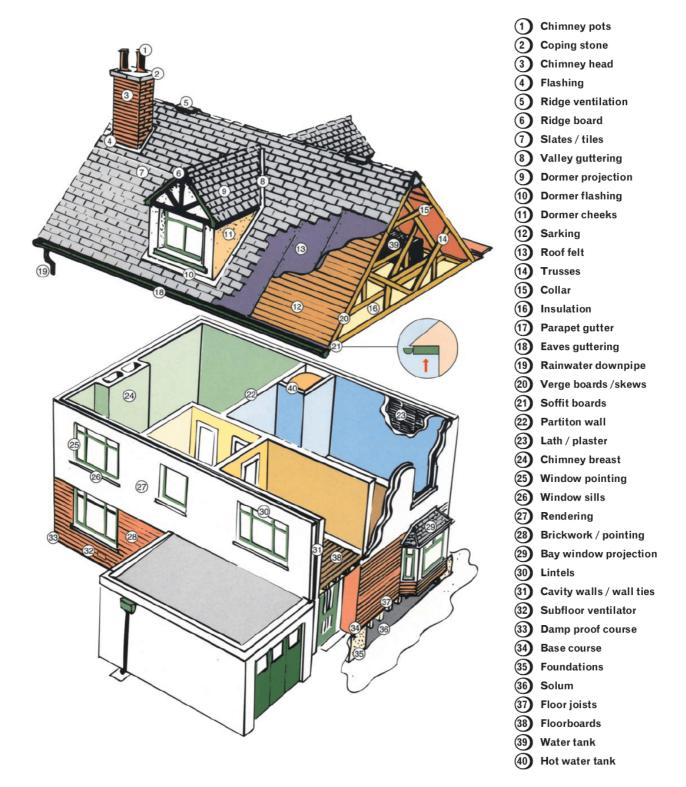
# Sectional Diagram showing elements of a typical house

Reference may be made in this report to some or all of the above component parts of the property. This diagram may assist you in locating and understanding these items.
