HOME
report

SINGLE SURVEY
ENERGY REPORT
PROPERTY QUESTIONNAIRE
VALUATION REPORT

Single Survey

Property Address	18 Logie Court Forres IV36 1GP
Customer	Ms TA Macaskill
Date of Inspection	21/03/2024
Prepared by	Douglas J H Mowat Harvey Donaldson & Gibson Chartered Surveyors

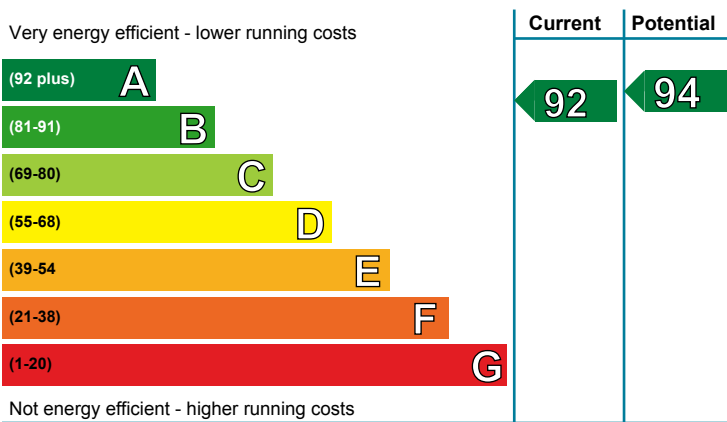
Energy Efficiency Rating

This graph shows the current efficiency of your home, taking into account both energy efficiency and fuel costs. The higher this rating, the lower your fuel bills are likely to be.

Your current rating is **band A (92)**. The average rating for EPCs in Scotland is **band D (61)**.

The potential rating shows the effect of undertaking all of the improvement measures listed within your recommendations report.
