# Single Survey

## Survey report on:

<b>Property Address</b>	Riach Cottage Longmorn Elgin IV30 8RN
<b>Customer</b>	Mr K West & Mrs S West
<b>Date of Inspection</b>	10/04/2024
<b>Prepared by</b>	Kenneth J Silver Harvey Donaldson & Gibson Chartered Surveyors

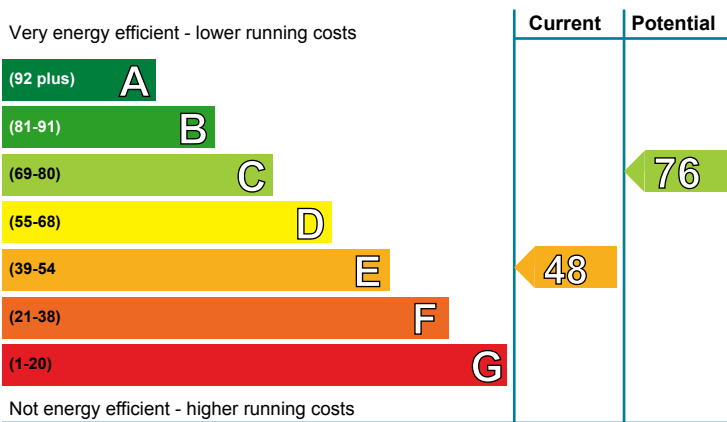
## Energy Efficiency Rating

This graph shows the current efficiency of your home, taking into account both energy efficiency and fuel costs. The higher this rating, the lower your fuel bills are likely to be.

Your current rating is **band E (48)**. The average rating for EPCs in Scotland is **band D (61)**.

The potential rating shows the effect of undertaking all of the improvement measures listed within your recommendations report.

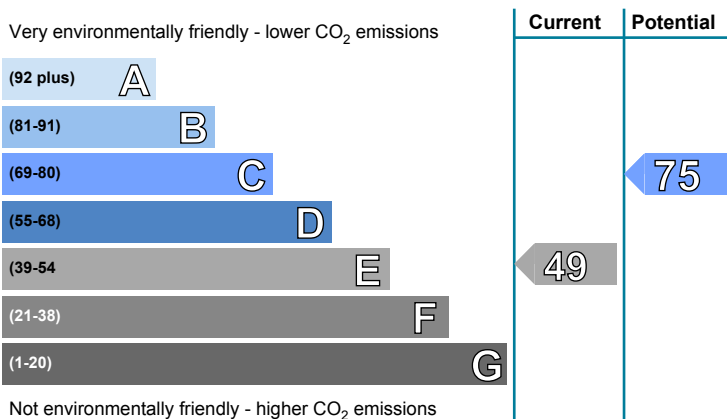
## Environmental Impact (CO<sub>2</sub>) Rating

This graph shows the effect of your home on the environment in terms of carbon dioxide (CO<sub>2</sub>) emissions. The higher the rating, the less impact it has on the environment.
