HOME
report

SINGLE SURVEY
ENERGY REPORT
PROPERTY QUESTIONNAIRE
VALUATION REPORT

Single Survey

Property Address	14 Mackenzie Court Elgin IV30 1AU
Customer	Mr K Munro & Mrs B Munro
Date of Inspection	02/07/2026
Prepared by	Kyle Mutch Harvey Donaldson & Gibson Chartered Surveyors

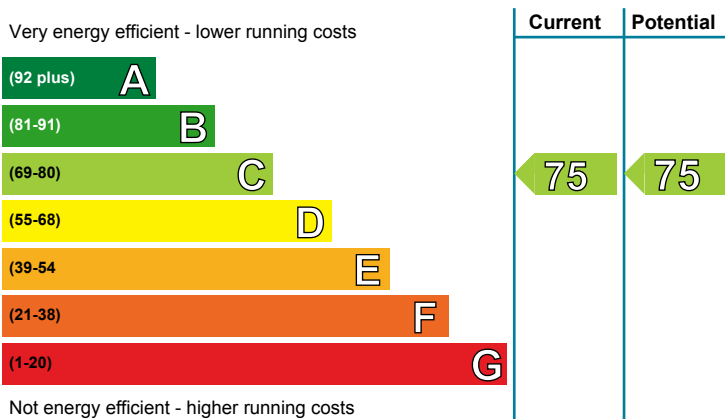
Energy Efficiency Rating

This graph shows the current efficiency of your home, taking into account both energy efficiency and fuel costs. The higher this rating, the lower your fuel bills are likely to be.

Your current rating is **band C (75)**. The average rating for EPCs in Scotland is **band D (61)**.

The potential rating shows the effect of undertaking all of the improvement measures listed within your recommendations report.

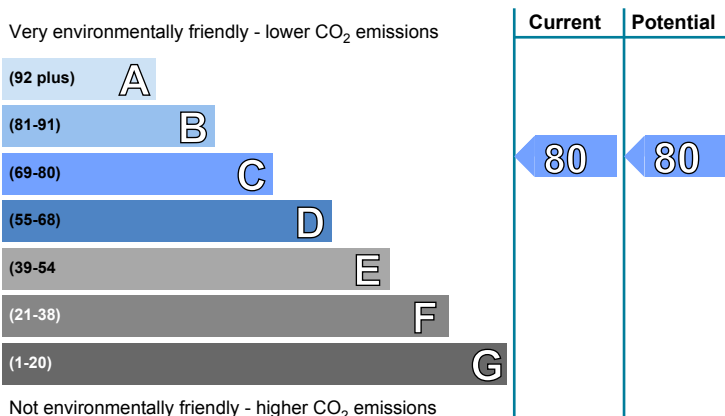
Environmental Impact (CO₂) Rating

This graph shows the effect of your home on the environment in terms of carbon dioxide (CO₂) emissions. The higher the rating, the less impact it has on the environment.
