HOME
report

SINGLE SURVEY
ENERGY REPORT
PROPERTY QUESTIONNAIRE
VALUATION REPORT

Single Survey

Property address	46 Milnefield Avenue, Elgin, IV30 6EL
-------------------------	---

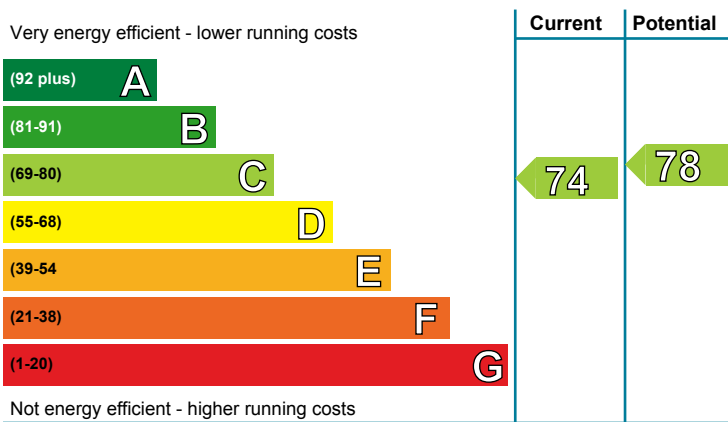
Energy Efficiency Rating

This graph shows the current efficiency of your home, taking into account both energy efficiency and fuel costs. The higher this rating, the lower your fuel bills are likely to be.

Your current rating is **band C (74)**. The average rating for EPCs in Scotland is **band D (61)**.

The potential rating shows the effect of undertaking all of the improvement measures listed within your recommendations report.

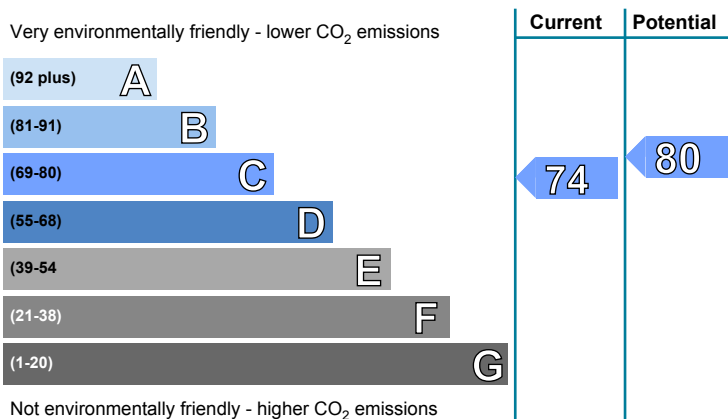
Environmental Impact (CO₂) Rating

This graph shows the effect of your home on the environment in terms of carbon dioxide (CO₂) emissions. The higher the rating, the less impact it has on the environment.
