HARVEY DONALDSON & GIBSON

survey report on:

Property address	10 Moravia Apartments, Pinefield Crescent, Elgin, IV30 6LN
Customer	Mr J Lowson
Customer address	35 Chanory Road, Elgin, IV30 1XH
Prepared by	Harvey Donaldson And Gibson
Date of inspection	19th February 2020

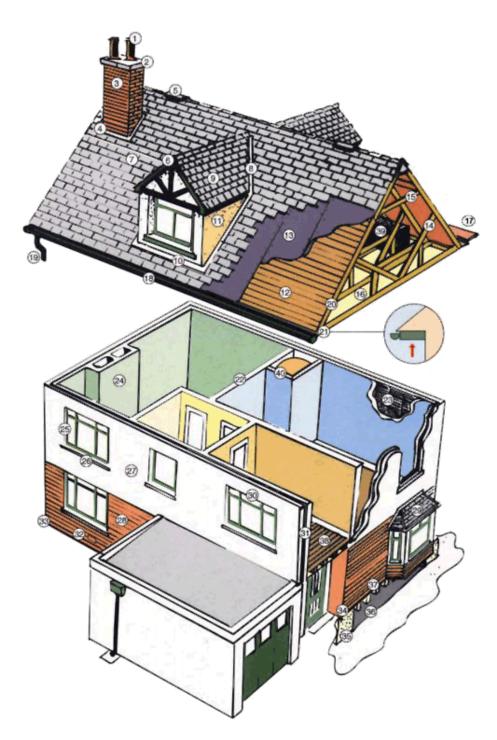
Sectional Diagram showing elements of a typical house

Reference may be made in this report to some or all of the above component parts of the property. This diagram may assist you in locating and understanding these items.

- 1) Chimney pots
- 2) Coping stone
- 3) Chimney head
- 4 Flashing
- 5 Ridge ventilation
- 6 Ridge board
- 7) Slates / tiles
- 8 Valley guttering
- 9 Dormer projection
- 10 Dormer flashing
- 11) Dormer cheeks
- 12) Sarking
- (13) Roof felt
- (14) Trusses
- (15) Collar
- 16 Insulation
- (17) Parapet gutter
- (18) Eaves guttering
- Rainwater downpipe
- 20) Verge boards/skews
- 21) Soffit boards
- 22) Partition wall
- 23) Lath / plaster
- 24) Chimney breast
- (25) Window pointing
- 6) Window sills
- 27) Rendering
- (28) Brickwork / pointing
- 29) Bay window projection
- 30 Lintels
- (31) Cavity walls / wall ties
- 32) Subfloor ventilator
- 33 Damp proof course
- 34) Base course
- 35) Foundations
- 36) Solum
- 37) Floor joists
- 38) Floorboards
- 39) Water tank
- 40) Hot water tank
