HOME
report

SINGLE SURVEY
ENERGY REPORT
PROPERTY QUESTIONNAIRE
VALUATION REPORT

| Property Address | 44 Moravia Court, Market Street Forres IV36 1EA |
| Prepared by | India Georgeson Harvey Donaldson & Gibson Chartered Surveyors |

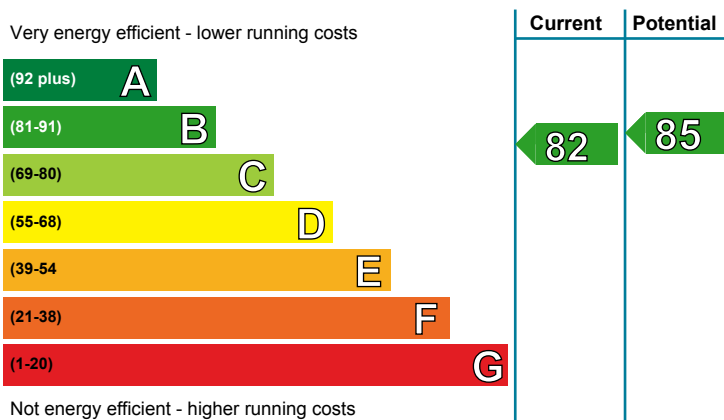
Energy Efficiency Rating

This graph shows the current efficiency of your home, taking into account both energy efficiency and fuel costs. The higher this rating, the lower your fuel bills are likely to be.

Your current rating is **band B (82)**. The average rating for EPCs in Scotland is **band D (61)**.

The potential rating shows the effect of undertaking all of the improvement measures listed within your recommendations report.

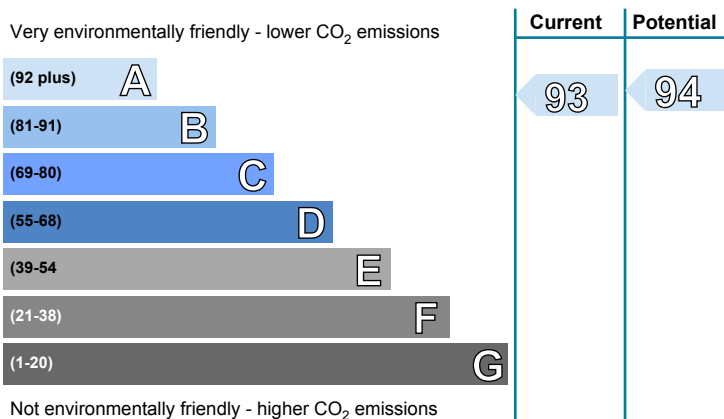
Environmental Impact (CO₂) Rating

This graph shows the effect of your home on the environment in terms of carbon dioxide (CO₂) emissions. The higher the rating, the less impact it has on the environment.
