HOME report

SINGLE SURVEY
ENERGY REPORT
PROPERTY QUESTIONNAIRE
VALUATION REPORT

Single Survey

Property Address	Rannoch Lodge Nelson Road Forres IV36 1DR
Customer	Mrs SM Beattie
Date of Inspection	06/09/2024
Prepared by	Donna Shields Harvey Donaldson & Gibson Chartered Surveyors

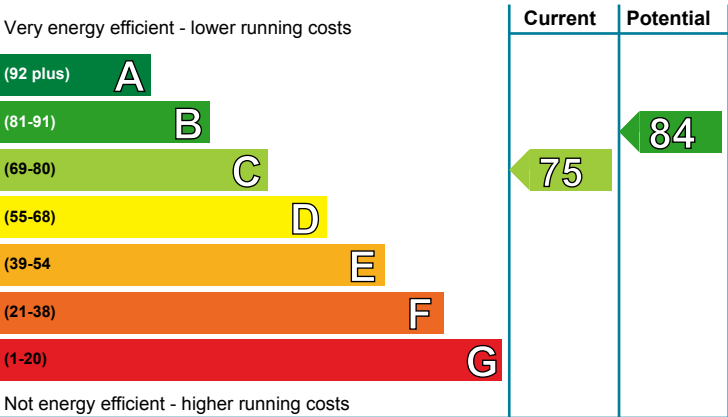
Energy Efficiency Rating

This graph shows the current efficiency of your home, taking into account both energy efficiency and fuel costs. The higher this rating, the lower your fuel bills are likely to be.

Your current rating is **band C (75)**. The average rating for EPCs in Scotland is **band D (61)**.

The potential rating shows the effect of undertaking all of the improvement measures listed within your recommendations report.

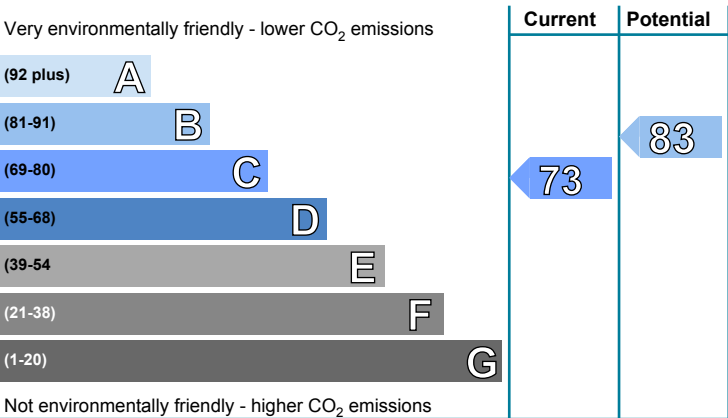
Environmental Impact (CO₂) Rating

This graph shows the effect of your home on the environment in terms of carbon dioxide (CO₂) emissions. The higher the rating, the less impact it has on the environment.
