Energy Performance Certificate (EPC)

FLAT C, 18 NEW STREET, PORTKNOCKIE, BUCKIE, AB56 4LR

Dwelling type: Mid-terrace house
Date of assessment: 05 December 2022
Date of certificate: 11 December 2022

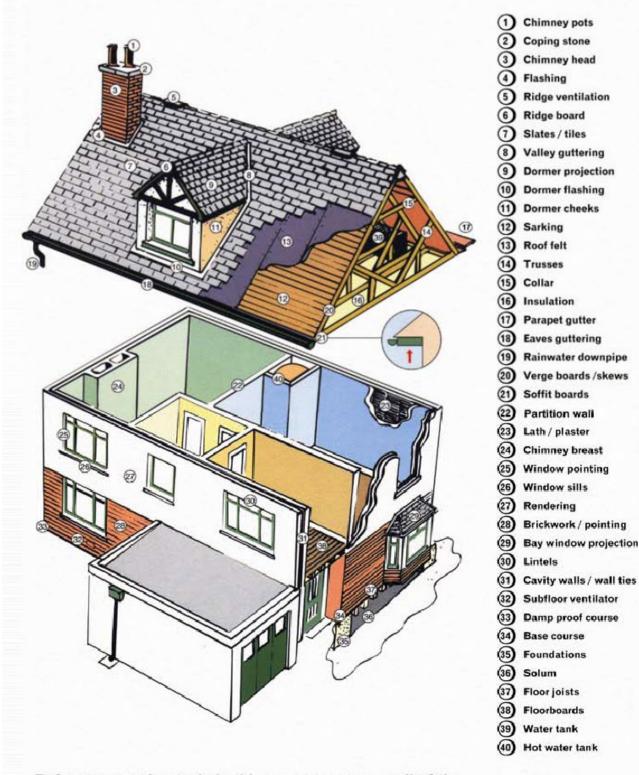
Sectional Diagram showing elements of a typical house

Reference may be made in this report to some or all of the above component parts of the property. This diagram may assist you in locating and understanding these items.
