**HOME**  
**report**

SINGLE SURVEY  
ENERGY REPORT  
PROPERTY QUESTIONNAIRE  
VALUATION REPORT

# Single Survey

<b>Property Address</b>	3 North Shore Findhorn IV36 3YQ
<b>Customer</b>	Ms C Tait
<b>Date of Inspection</b>	04/02/2026
<b>Prepared by</b>	Donna Shields Harvey Donaldson & Gibson Chartered Surveyors

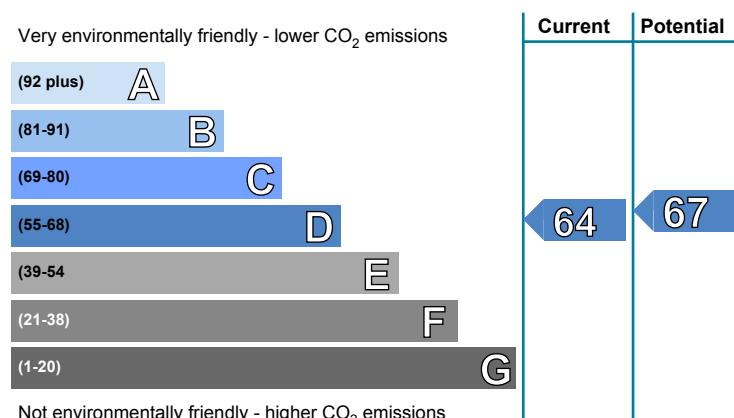
## Environmental Impact (CO<sub>2</sub>) Rating

This graph shows the effect of your home on the environment in terms of carbon dioxide (CO<sub>2</sub>) emissions. The higher the rating, the less impact it has on the environment.
