# **HOME REPORT**

45 NORTH STREET
BISHOPMILL
ELGIN
IV30 4EE

# SINGLE SURVEY

# survey report on:

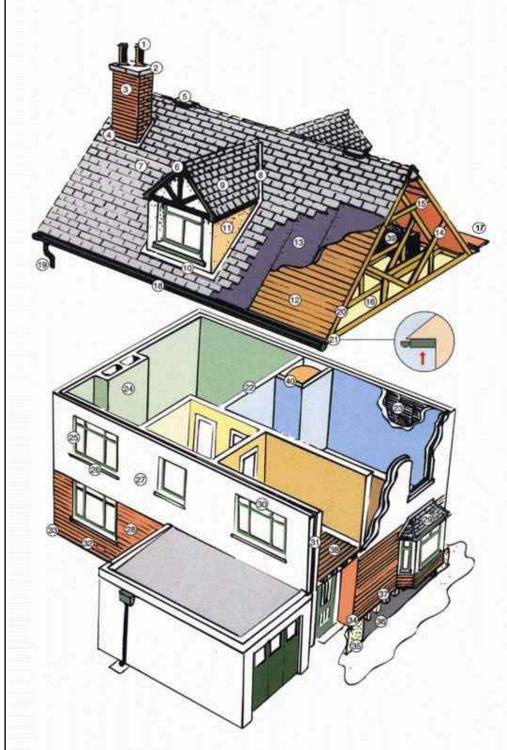
#### Sectional Diagram showing elements of a typical house

Reference may be made in this report to some or all of the above component parts of the property. This diagram may assist you in locating and understanding these items.

- 1 Chimney pots
- (2) Coping stone
- 3) Chimney head
- 4 Flashing
- 5) Ridge ventilation
- 6) Ridge board
- 7) Slates / tiles
- (8) Valley guttering
- 9) Dormer projection
- 10 Dormer flashing
- 11) Dormer cheeks
- 12) Sarking
- (13) Roof felt
- (14) Trusses
- 15) Collar
- (16) Insulation
  - 7) Parapet gutter
- 18) Eaves guttering
- 19) Rainwater downpipe
- 0) Verge boards /skews
- 21) Soffit boards
- 22) Partition wall
- 23) Lath / plaster
- 24) Chimney breast
- (25) Window pointing
- 26) Window sills
- (27) Rendering
- (28) Brickwork / pointing
- (29) Bay window projection
- (30) Lintels
- (31) Cavity walls / wall ties
- 32) Subfloor ventilator
- 33) Damp proof course
- 34) Base course
- 35) Foundations
- (36) Solum
- 37) Floor joists
- 38) Floorboards
- 9) Water tank
- 10) Hot water tank
