HOME REPORT

GLENMORE ORCHARD ROAD

FORRES
IV36 1LH

Energy Performance Certificate (EPC)

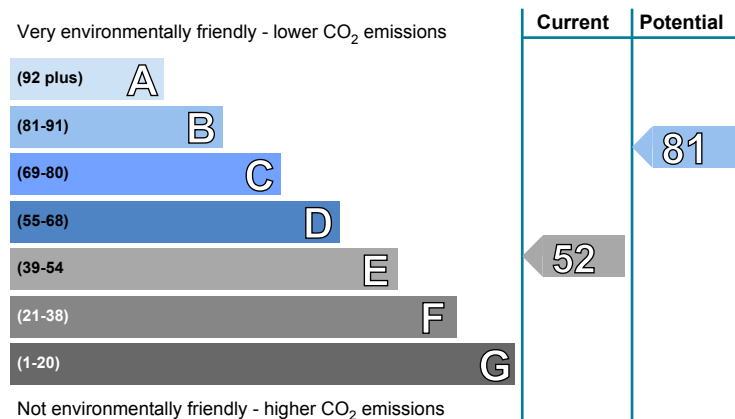
Environmental Impact (CO₂) Rating

This graph shows the effect of your home on the environment in terms of carbon dioxide (CO₂) emissions. The higher the rating, the less impact it has on the environment.

Your current rating is **band E (52)**. The average rating for EPCs in Scotland is **band D (59)**.

The potential rating shows the effect of undertaking all of the improvement measures listed within your recommendations report.
