survey report on:

The Neuk, Forres, IV36 2QG Customer Mr R Patience Customer address The Neuk, Forres, IV36 2QG	and the state of t
Customer address The Neuk,	roperty address
Customer address The Neuk,	
	ustomer
	ustomer address
Prepared by Harvey Donaldson And Gibson	repared by
Date of inspection 28th July 2022	ate of inspection

PART 1 - GENERAL

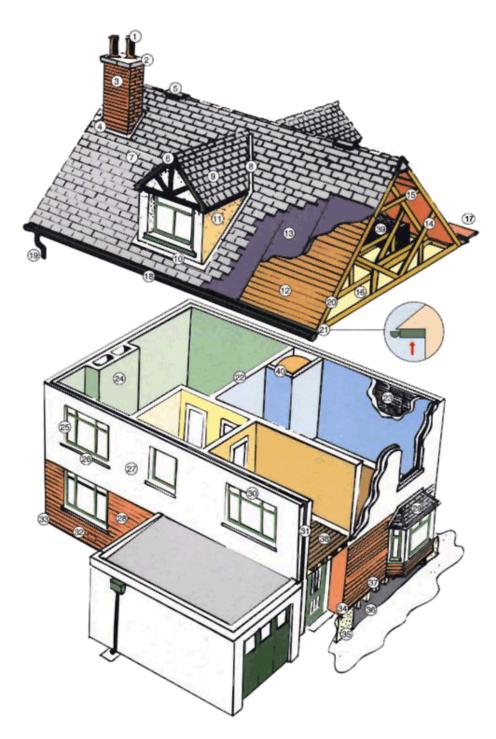
Sectional Diagram showing elements of a typical house

Reference may be made in this report to some or all of the above component parts of the property. This diagram may assist you in locating and understanding these items.

- 1) Chimney pots
- 2) Coping stone
- 3) Chimney head
- 4 Flashing
- 5 Ridge ventilation
- 6) Ridge board
- 7) Slates / tiles
- 8 Valley guttering
- Dormer projection
- 10) Dormer flashing
- 11) Dormer cheeks
- (12) Sarking
- (13) Roof felt
- (14) Trusses
- 15) Collar
- (16) Insulation
- (17) Parapet gutter
- (18) Eaves guttering
- 19) Rainwater downpipe
- 20) Verge boards /skews
- 21) Soffit boards
- 22) Partition wall
- 23) Lath / plaster
- (24) Chimney breast
- (25) Window pointing
 - 6) Window sills
- 27) Rendering
- (28) Brickwork / pointing
- 29 Bay window projection
- 30 Lintels
- (31) Cavity walls / wall ties
- 32) Subfloor ventilator
- 33 Damp proof course
- 34) Base course
- 35) Foundations
- 36) Solum
- 37) Floor joists
- 38) Floorboards
- 39) Water tank
- 40) Hot water tank
