HOME REPORT

RARICHIE DALLAS

FORRES
IV36 2SA

Single Survey

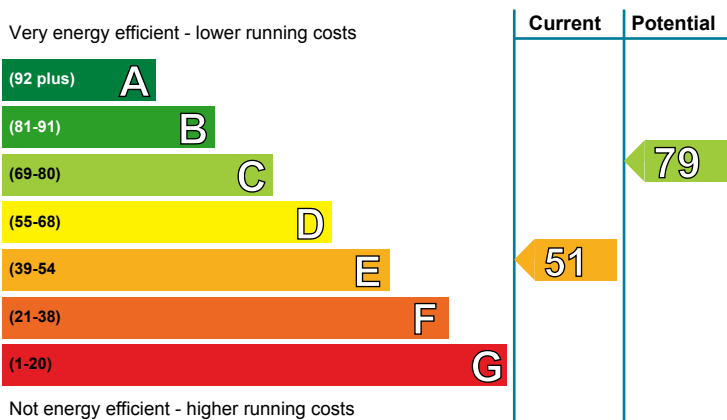
Energy Efficiency Rating

This graph shows the current efficiency of your home, taking into account both energy efficiency and fuel costs. The higher this rating, the lower your fuel bills are likely to be.

Your current rating is **band E (51)**. The average rating for EPCs in Scotland is **band D (61)**.

The potential rating shows the effect of undertaking all of the improvement measures listed within your recommendations report.

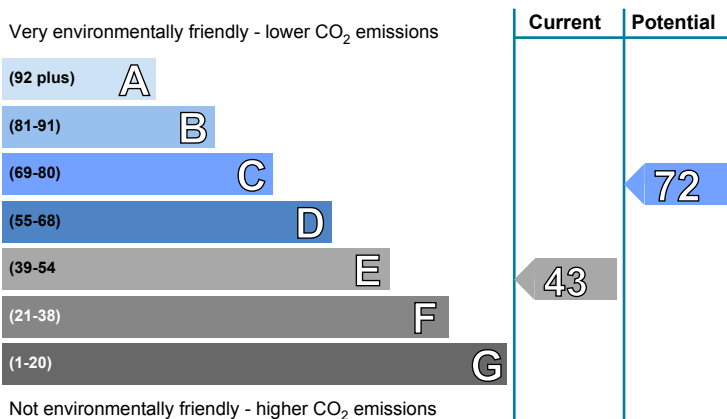
Environmental Impact (CO₂) Rating

This graph shows the effect of your home on the environment in terms of carbon dioxide (CO₂) emissions. The higher the rating, the less impact it has on the environment.

Your current rating is **band E (43)**. The average rating for EPCs in Scotland is **band D (59)**.

The potential rating shows the effect of undertaking all of the improvement measures listed within your recommendations report.
