HARVEY DONALDSON & GIBSON

survey report on:

saivey report on:	
Property address	18 Red Craig Drive, Burghead, Elgin, IV30 5ZF
Customer	Mrs S Graham, Mr C Fraser (POA)
Customer address	
Prepared by	Harvey Donaldson And Gibson
Date of inspection	7th July 2023

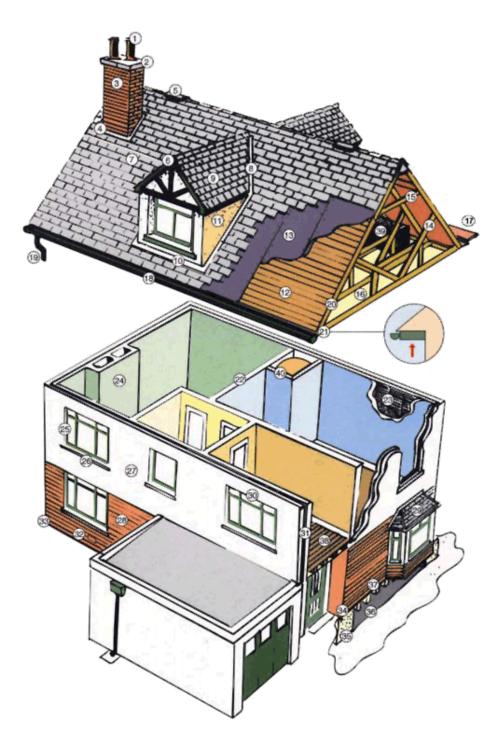
Sectional Diagram showing elements of a typical house

Reference may be made in this report to some or all of the above component parts of the property. This diagram may assist you in locating and understanding these items.

- 1) Chimney pots
- 2) Coping stone
- 3) Chimney head
- 4 Flashing
- 5 Ridge ventilation
- 6) Ridge board
- 7) Slates / tiles
- 8 Valley guttering
- 9 Dormer projection
- 10 Dormer flashing
- 11) Dormer cheeks
- (12) Sarking
- (13) Roof felt
- (14) Trusses
- (15) Collar
- 16 Insulation
- 17) Parapet gutter
- 18) Eaves guttering
- 19) Rainwater downpipe
- 20) Verge boards/skews
- 21) Soffit boards
- 22) Partition wall
- 23) Lath / plaster
- 24) Chimney breast
- (25) Window pointing
 - 6) Window sills
- 27) Rendering
- (28) Brickwork / pointing
- 29) Bay window projection
- 30 Lintels
- (31) Cavity walls / wall ties
- 32) Subfloor ventilator
- 33 Damp proof course
- 34) Base course
- 35) Foundations
- (36) Solum
- 37) Floor joists
- 38) Floorboards
- 39) Water tank
- 40) Hot water tank
