- 1. Single Survey
- 2. Energy Report
- 3. Property Questionnaire

survey report on:

,	
Property address	28 Riddock Gardens, Forres, IV36 2QE
Customer	Mr R Stevenson
Customer address	
Prepared by	Harvey, Donaldson and Gibson
Date of inspection	16th August 2023

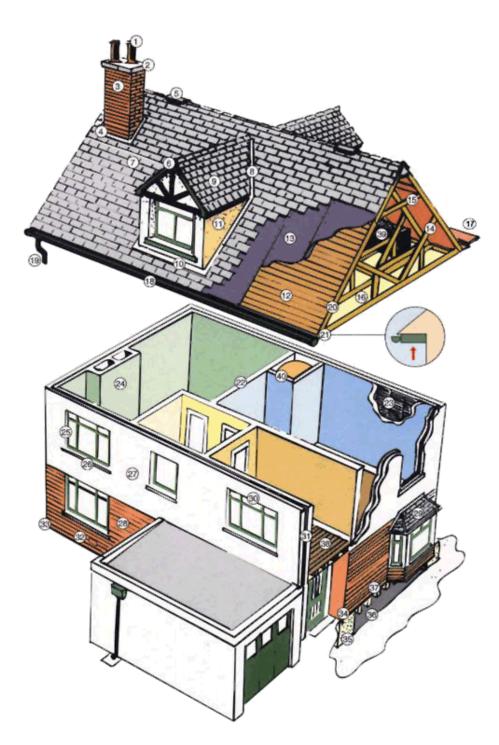
Sectional Diagram showing elements of a typical house

Reference may be made in this report to some or all of the above component parts of the property. This diagram may assist you in locating and understanding these items.

- 1) Chimney pots
- 2) Coping stone
- 3) Chimney head
- 4 Flashing
- 5 Ridge ventilation
- 6 Ridge board
- 7) Slates / tiles
- 8 Valley guttering
- 9 Dormer projection
- 10) Dormer flashing
- 11) Dormer cheeks
- 12) Sarking
- (13) Roof felt
- (14) Trusses
- (15) Collar
- 16 Insulation
- 17) Parapet gutter
- 18) Eaves guttering
- (19) Rainwater downpipe
- 20) Verge boards/skews
- 21) Soffit boards
- 22) Partition wall
- 23) Lath / plaster
- 24) Chimney breast
- 25) Window pointing
- 6) Window sills
- 27) Rendering
- (28) Brickwork / pointing
- 29) Bay window projection
- 30 Lintels
- 31) Cavity walls / wall ties
- 32) Subfloor ventilator
- 33 Damp proof course
- 34) Base course
- 35) Foundations
- 36) Solum
- Floor joists
- 38) Floorboards
- 39) Water tank
- 40 Hot water tank
