HOME
report

SINGLE SURVEY
ENERGY REPORT
PROPERTY QUESTIONNAIRE
VALUATION REPORT

Property Address	4 Robertson Place Forres IV36 1EU
Customer	Miss J Mitchell
Date of Inspection	21/05/2026
Prepared by	Donna Shields Harvey Donaldson & Gibson Chartered Surveyors

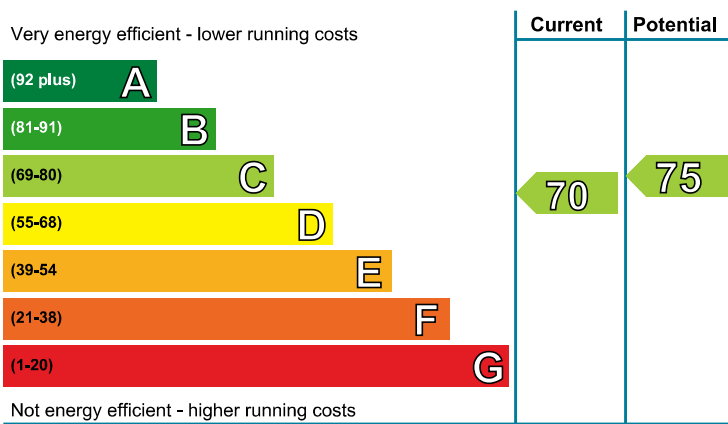
Energy Efficiency Rating

This graph shows the current efficiency of your home, taking into account both energy efficiency and fuel costs. The higher this rating, the lower your fuel bills are likely to be.

Your current rating is **band C (70)**. The average rating for EPCs in Scotland is **band D (61)**.

The potential rating shows the effect of undertaking all of the improvement measures listed within your recommendations report.

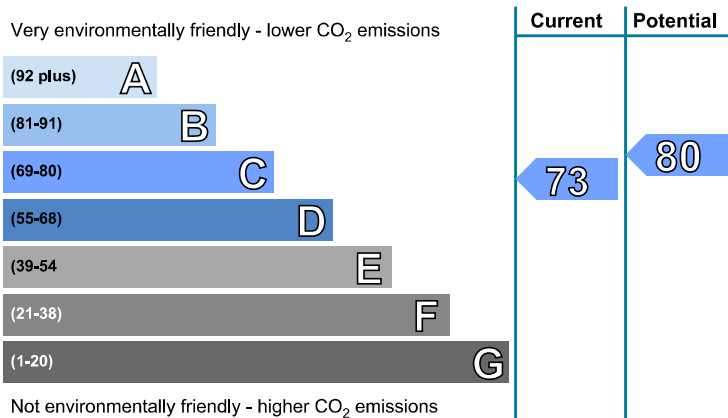
Environmental Impact (CO₂) Rating

This graph shows the effect of your home on the environment in terms of carbon dioxide (CO₂) emissions. The higher the rating, the less impact it has on the environment.
