8 SMIDDY PLACE

Home Report

8 SMIDDY PLACE, ALVES, ELGIN, IV30 8XG

Scottish Single Survey

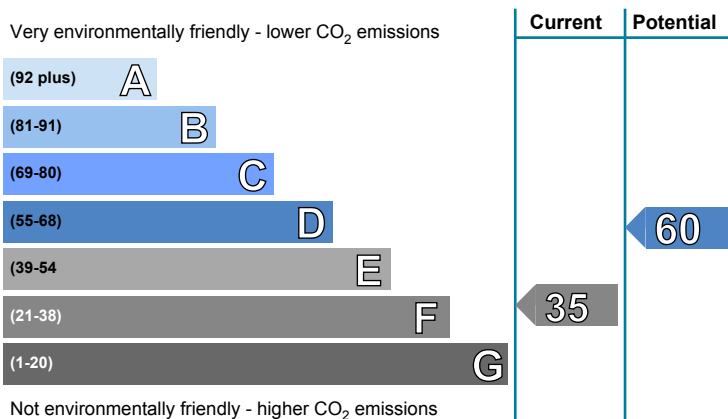
Environmental Impact (CO₂) Rating

This graph shows the effect of your home on the environment in terms of carbon dioxide (CO₂) emissions. The higher the rating, the less impact it has on the environment.

The potential rating shows the effect of undertaking all of the improvement measures listed within your recommendations report.
