HOME
report

SINGLE SURVEY
ENERGY REPORT
PROPERTY QUESTIONNAIRE
VALUATION REPORT

Single Survey

Property address	Hollybrae, South Darkland, Lhanbryde, Elgin, IV30 8NT
-------------------------	---

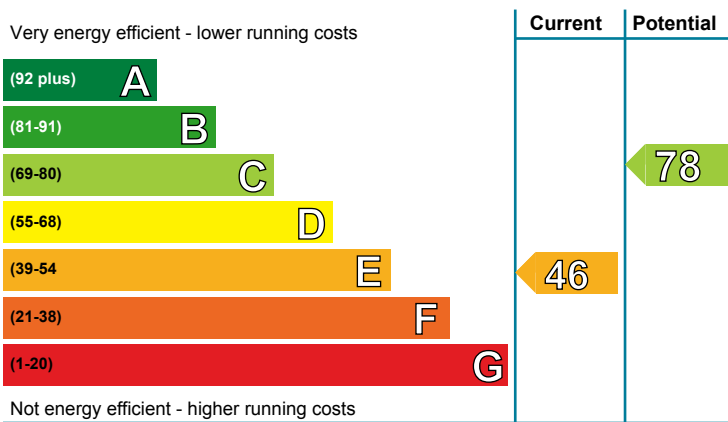
Energy Efficiency Rating

This graph shows the current efficiency of your home, taking into account both energy efficiency and fuel costs. The higher this rating, the lower your fuel bills are likely to be.

Your current rating is **band E (46)**. The average rating for EPCs in Scotland is **band D (61)**.

The potential rating shows the effect of undertaking all of the improvement measures listed within your recommendations report.
