# HOME REPORT

ST CATHERINES HOUSE ST CATHERINES ROAD

FORRES  
IV36 1LS

# Energy Performance Certificate (EPC)

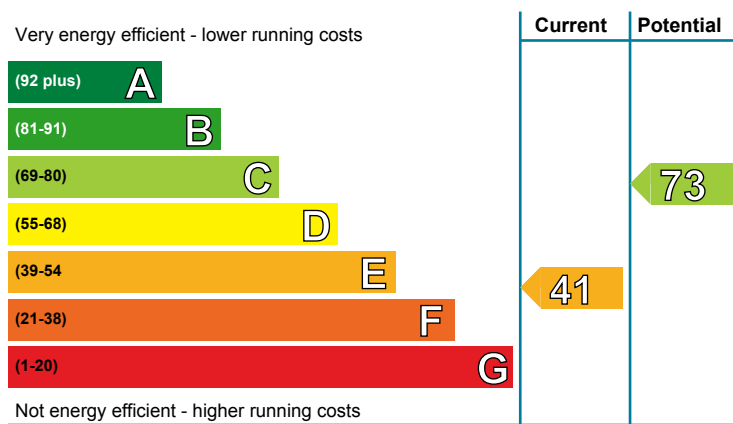
## Energy Efficiency Rating

This graph shows the current efficiency of your home, taking into account both energy efficiency and fuel costs. The higher this rating, the lower your fuel bills are likely to be.

Your current rating is **band E (41)**. The average rating for EPCs in Scotland is **band D (61)**.

The potential rating shows the effect of undertaking all of the improvement measures listed within your recommendations report.
