# SINGLE SURVEY

## survey report on:

Property address	12 St John's Court Hay Street Elgin IV30 1NG
Customer	Mr CA Toynton
Customer address	12 St John's Court Hay Street Elgin IV30 1NG
Prepared by	Mark McClelland-Jones, AssocRICS
Date of inspection	10th June 2025

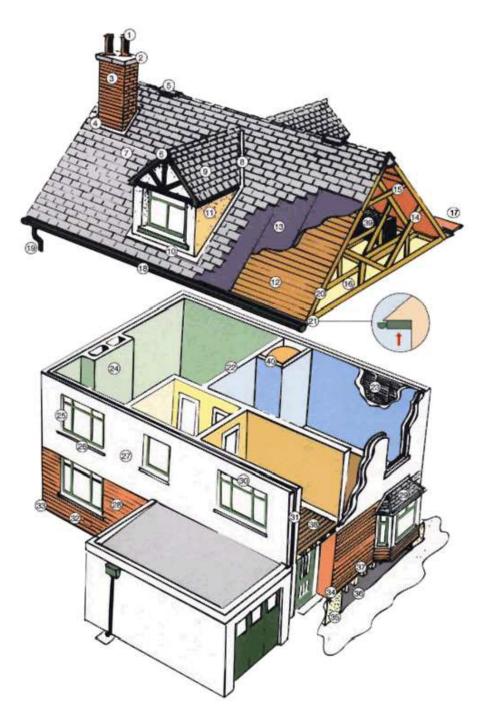
## Sectional Diagram showing elements of a typical house

Reference may be made in this report to some or all of the above component parts of the property. This diagram may assist you in locating and understanding these items.

- 1) Chimney pots
- 2 Coping stone
- 3 Chimney head
- 4 Flashing
- 5 Ridge ventilation
- 6 Ridge board
- (7) Slates / tiles
- 8 Valley guttering
- 9 Dormer projection
- 10 Dormer flashing
- 11) Dormer cheeks
- 12) Sarking
- 13) Roof felt
- 14) Trusses
- 15) Collar
- (16) Insulation
- 17) Parapet gutter
- 18) Eaves guttering
- (19) Rainwater downpipe
- 20) Verge boards /skews
- 21) Soffit boards
- 22) Partition wall
- (23) Lath / plaster
- (24) Chimney breast
- (25) Window pointing
- (26) Window sills
- 27) Rendering
- 28) Brickwork / pointing
- 29 Bay window projection
- 30 Lintels
- (31) Cavity walls / wall ties
- 32) Subfloor ventilator
- (33) Damp proof course
- (34) Base course
- (35) Foundations
- (36) Solum
- (37) Floor joists
- (38) Floorboards
- 39) Water tank
- 40 Hot water tank
