HOME REPORT

15 ST RONANS ROAD
FORRES
IV36 1BQ

Energy Performance Certificate (EPC)

15 ST RONANS ROAD, FORRES, IV36 1BQ

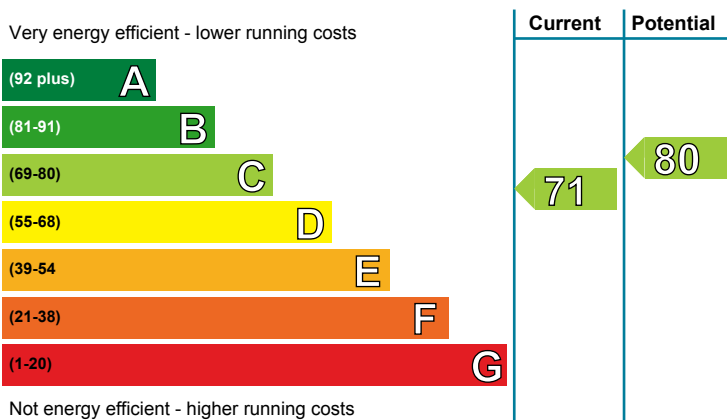
Energy Efficiency Rating

This graph shows the current efficiency of your home, taking into account both energy efficiency and fuel costs. The higher this rating, the lower your fuel bills are likely to be.

Your current rating is **band C (71)**. The average rating for EPCs in Scotland is **band D (61)**.

The potential rating shows the effect of undertaking all of the improvement measures listed within your recommendations report.
