HOME
report

SINGLE SURVEY
ENERGY REPORT
PROPERTY QUESTIONNAIRE
VALUATION REPORT

Single Survey

Property address	Steinish, Forres, IV36 2QT
-------------------------	----------------------------------

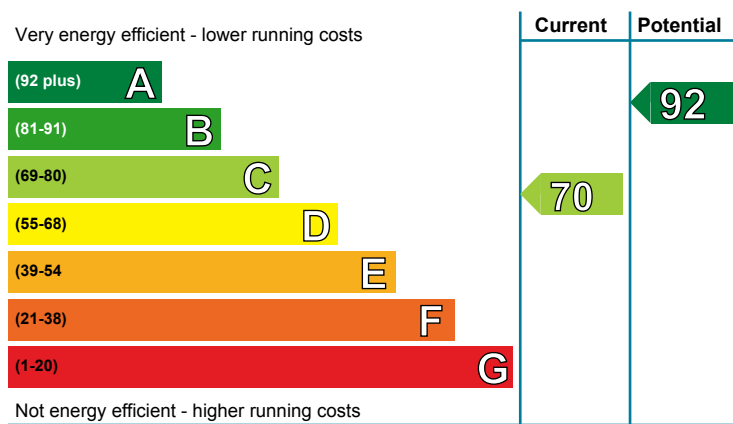
Energy Efficiency Rating

This graph shows the current efficiency of your home, taking into account both energy efficiency and fuel costs. The higher this rating, the lower your fuel bills are likely to be.

Your current rating is **band C (70)**. The average rating for EPCs in Scotland is **band D (61)**.

The potential rating shows the effect of undertaking all of the improvement measures listed within your recommendations report.

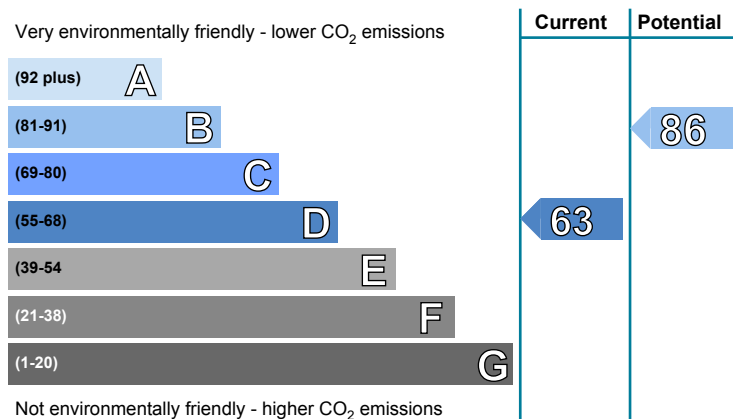
Environmental Impact (CO₂) Rating

This graph shows the effect of your home on the environment in terms of carbon dioxide (CO₂) emissions. The higher the rating, the less impact it has on the environment.
