**HOME**  
report

SINGLE SURVEY  
ENERGY REPORT  
PROPERTY QUESTIONNAIRE  
VALUATION REPORT

# Single Survey

<b>Property address</b>	Tides Edge Cottage, 4 Findhorn, Forres, IV36 3YE
-------------------------	---

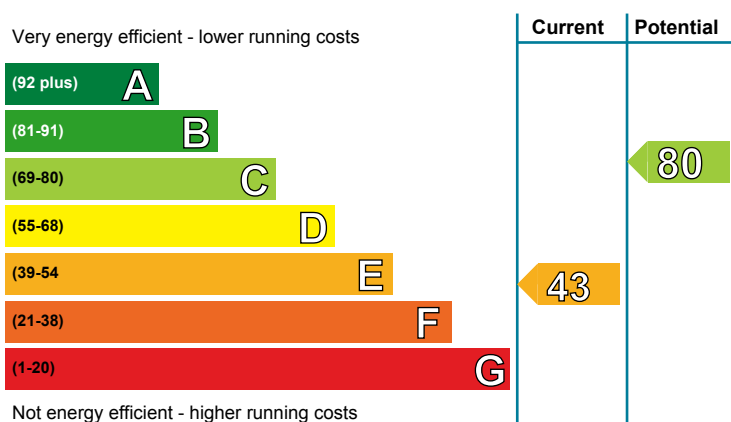
## Energy Efficiency Rating

This graph shows the current efficiency of your home, taking into account both energy efficiency and fuel costs. The higher this rating, the lower your fuel bills are likely to be.

Your current rating is **band E (43)**. The average rating for EPCs in Scotland is **band D (61)**.

The potential rating shows the effect of undertaking all of the improvement measures listed within your recommendations report.

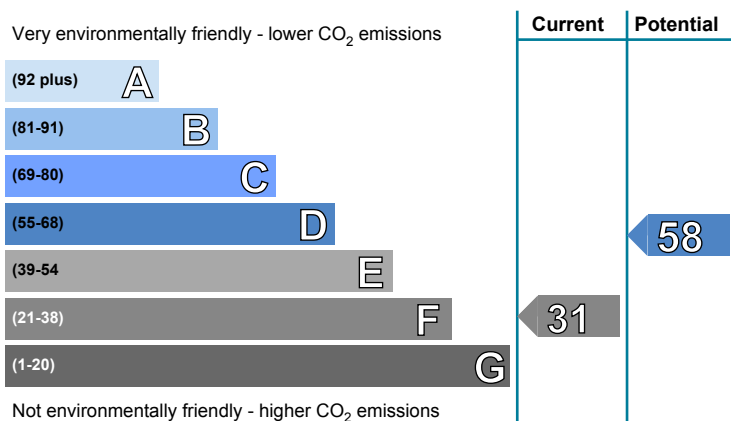
## Environmental Impact (CO<sub>2</sub>) Rating

This graph shows the effect of your home on the environment in terms of carbon dioxide (CO<sub>2</sub>) emissions. The higher the rating, the less impact it has on the environment.
