HOME
report

SINGLE SURVEY
ENERGY REPORT
PROPERTY QUESTIONNAIRE
VALUATION REPORT

Single Survey

Property address	Tulloch Cottage, Rafford, Forres, IV36 2SL
-------------------------	---

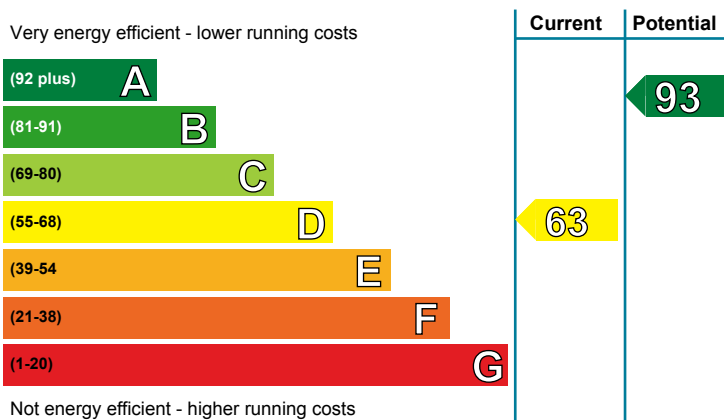
Energy Efficiency Rating

This graph shows the current efficiency of your home, taking into account both energy efficiency and fuel costs. The higher this rating, the lower your fuel bills are likely to be.

Your current rating is **band D (63)**. The average rating for EPCs in Scotland is **band D (61)**.

The potential rating shows the effect of undertaking all of the improvement measures listed within your recommendations report.

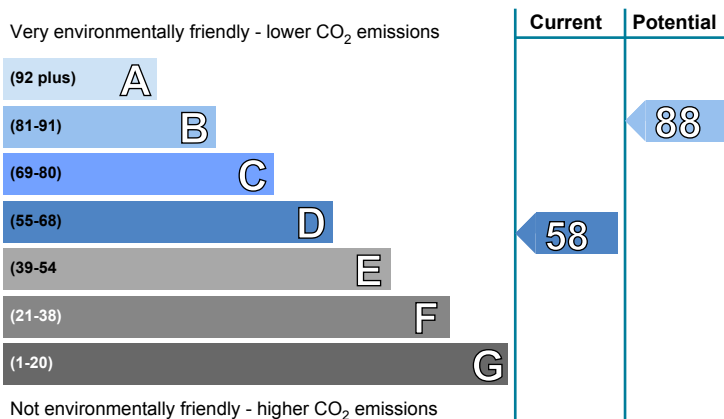
Environmental Impact (CO₂) Rating

This graph shows the effect of your home on the environment in terms of carbon dioxide (CO₂) emissions. The higher the rating, the less impact it has on the environment.
