**HOME**  
report

SINGLE SURVEY  
ENERGY REPORT  
PROPERTY QUESTIONNAIRE  
VALUATION REPORT

<b>Property address</b>	4 Woodside Place, Fochabers, IV32 7HE
-------------------------	---

<b>Date of inspection</b>	27th July 2020
---------------------------	----------------

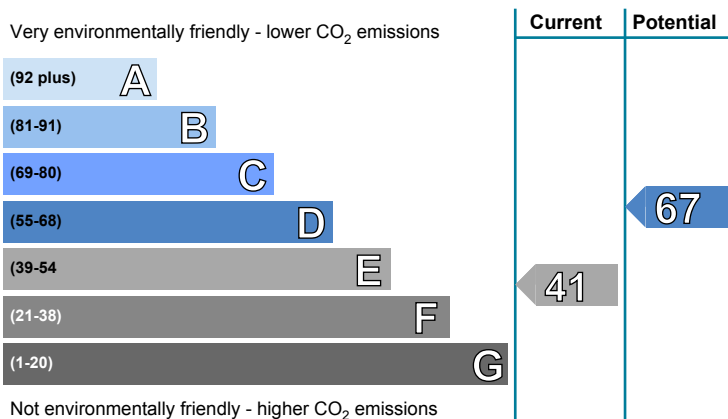
## Environmental Impact (CO<sub>2</sub>) Rating

This graph shows the effect of your home on the environment in terms of carbon dioxide (CO<sub>2</sub>) emissions. The higher the rating, the less impact it has on the environment.
